SKI-DOO/LYNX 850 Turbo Gears & Chain_141028

Type:
General

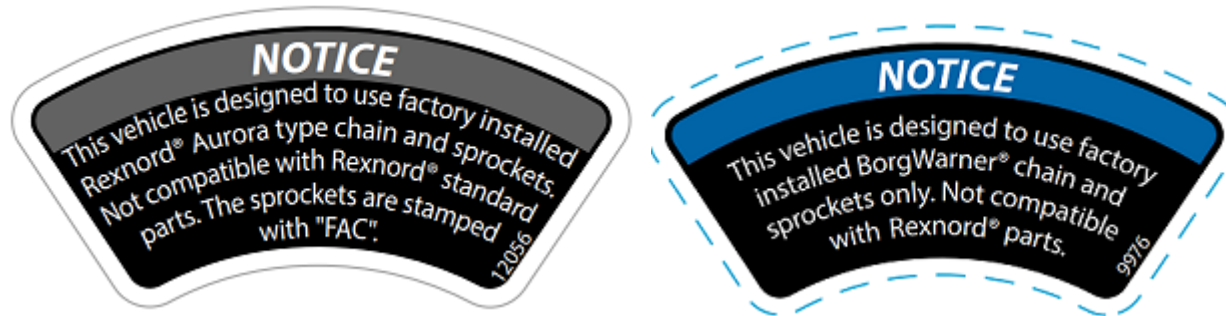
The chain case will have a sticker notifying you if there are other parts installed then the normal Rexnord parts.

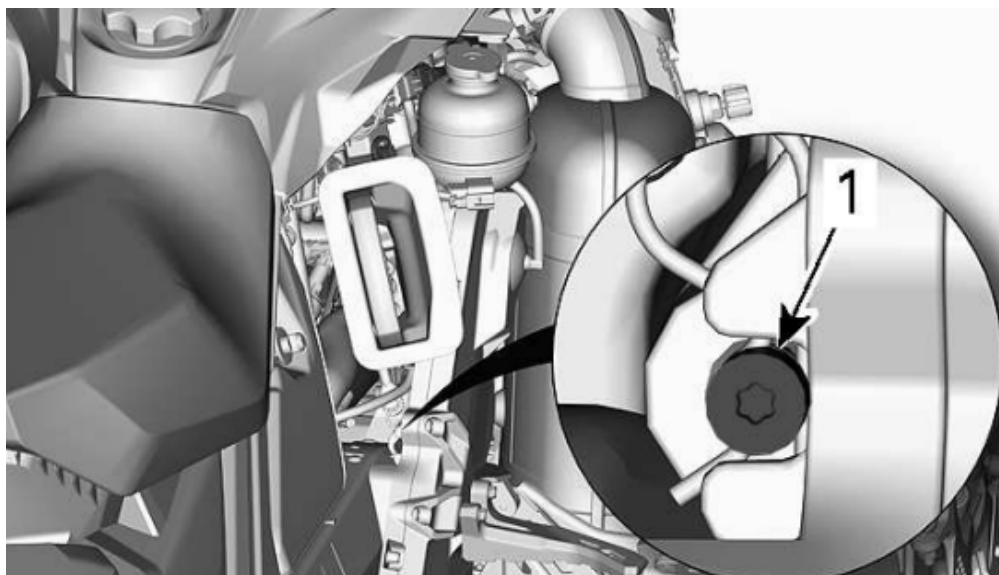
Chain tension is a critical factor to the chain/gear system, for deep snow the intervalls are: 75/500/1000/1500/3000/6000km (50/300/600/1000/2000/4000mi)

Overtightening the drive chain could result in severe damage to the chaincase components

Using the Torx end of the driven pulley expander, GENTLY turn tensioner clockwise to eliminate the play
