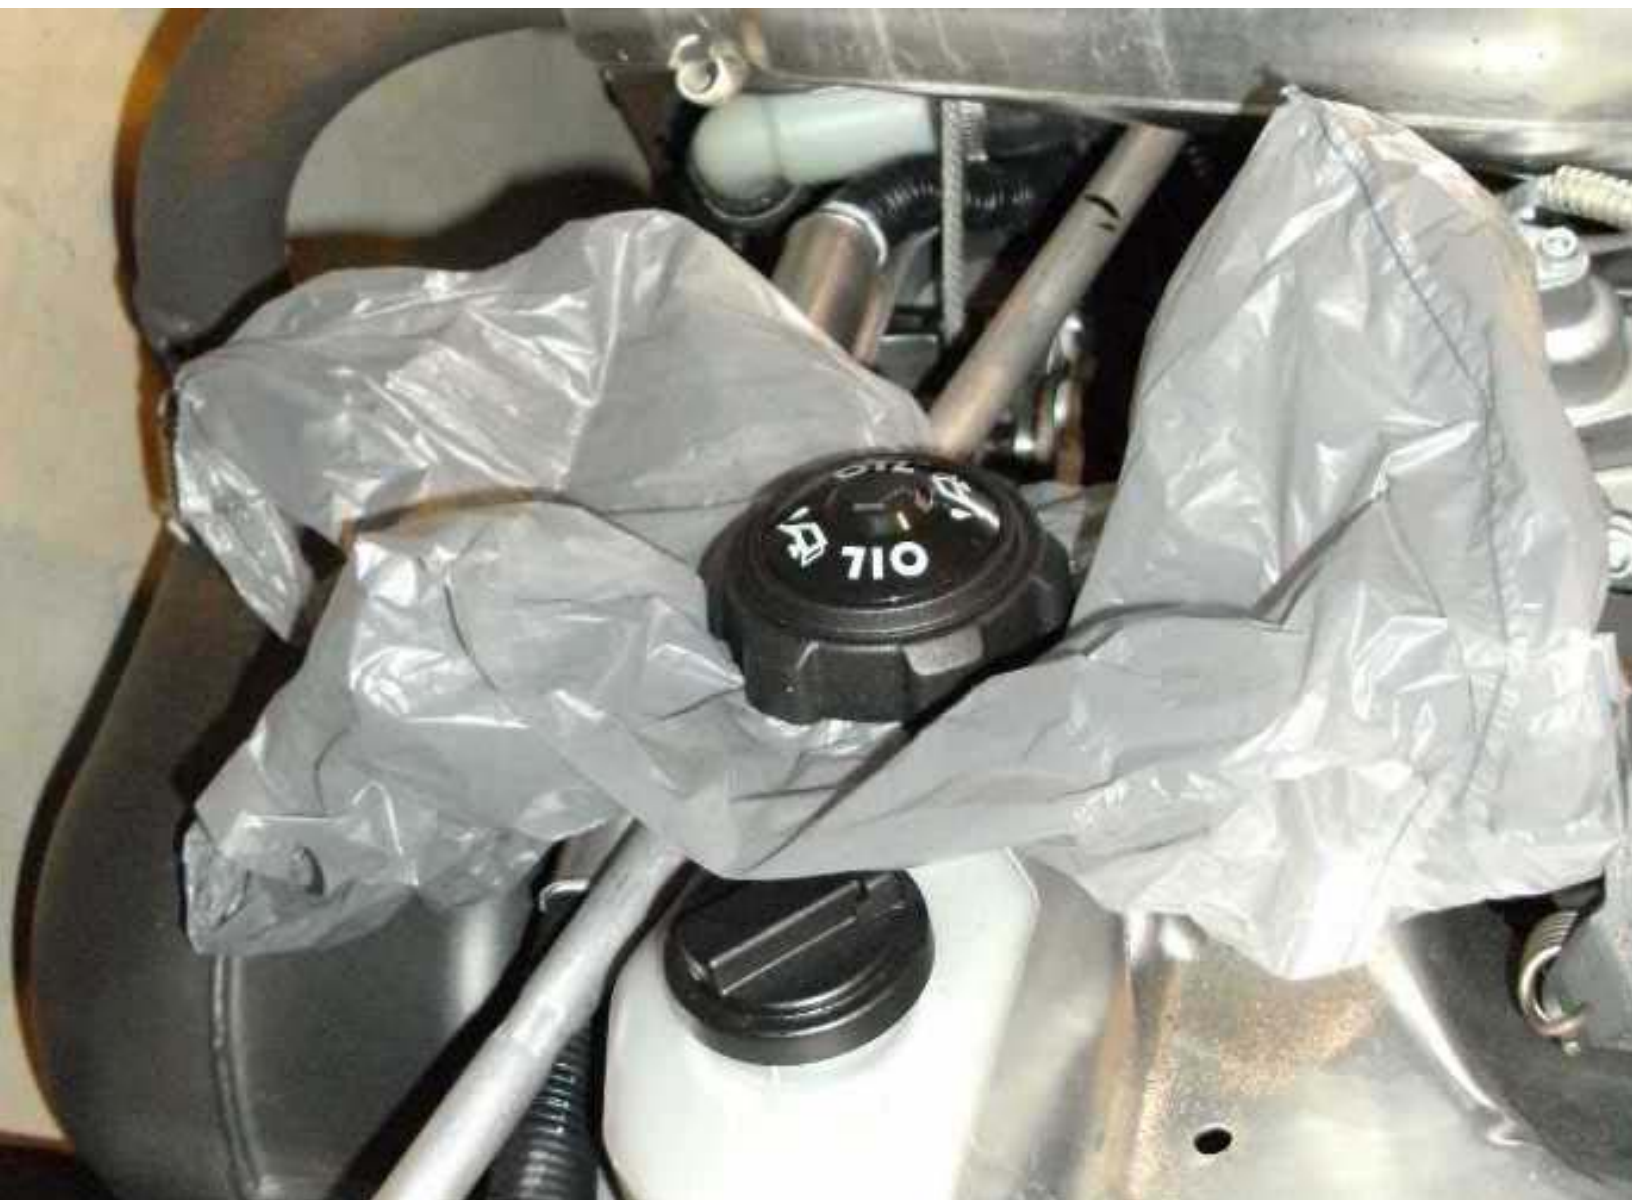
Wal-Mart sack, doubled over (4 layers) poked loose into the oil reservoir. Screwed cap on, just like normal. No leaks when tipped on side.

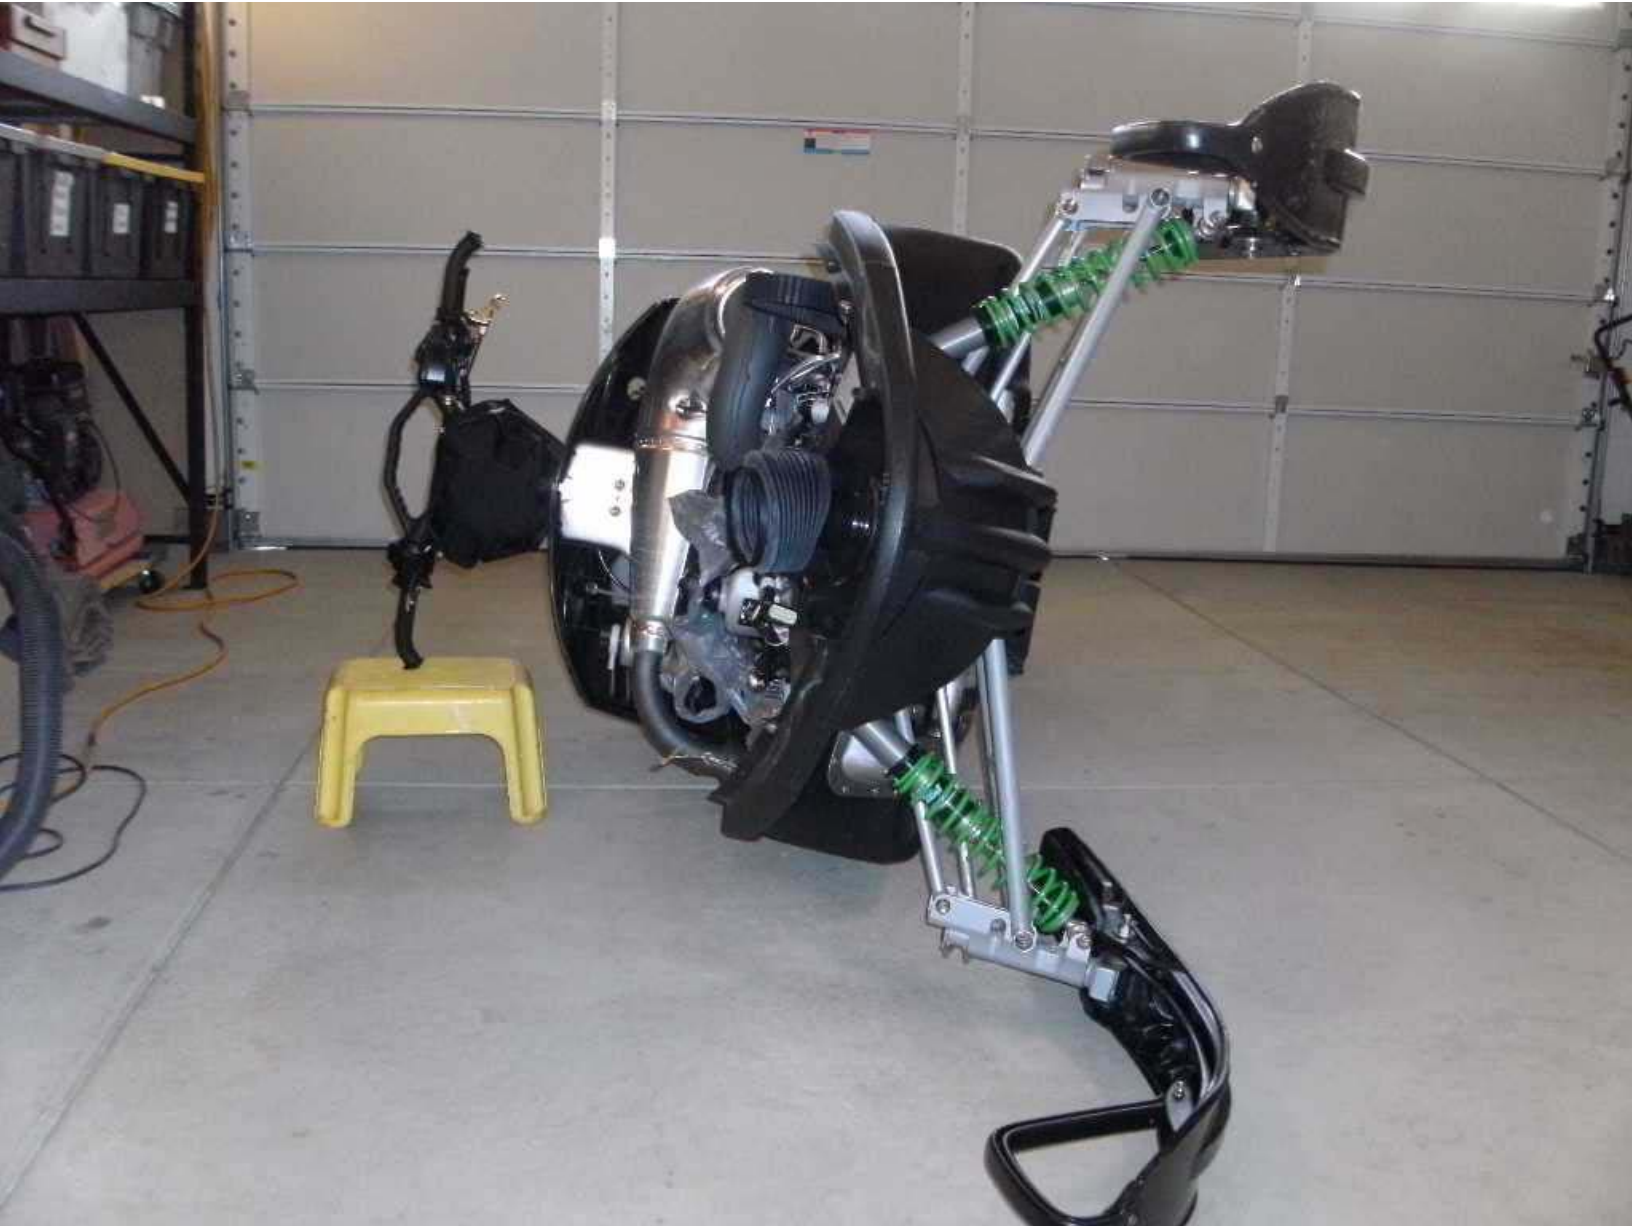
Removed hood, side panels, and driven clutch.  
Need T-25 torx bit for side panels, 14 mm for clutch.  
Tipped sled on side, supported by Rubbermaid stool.  
Oil stays in DD.

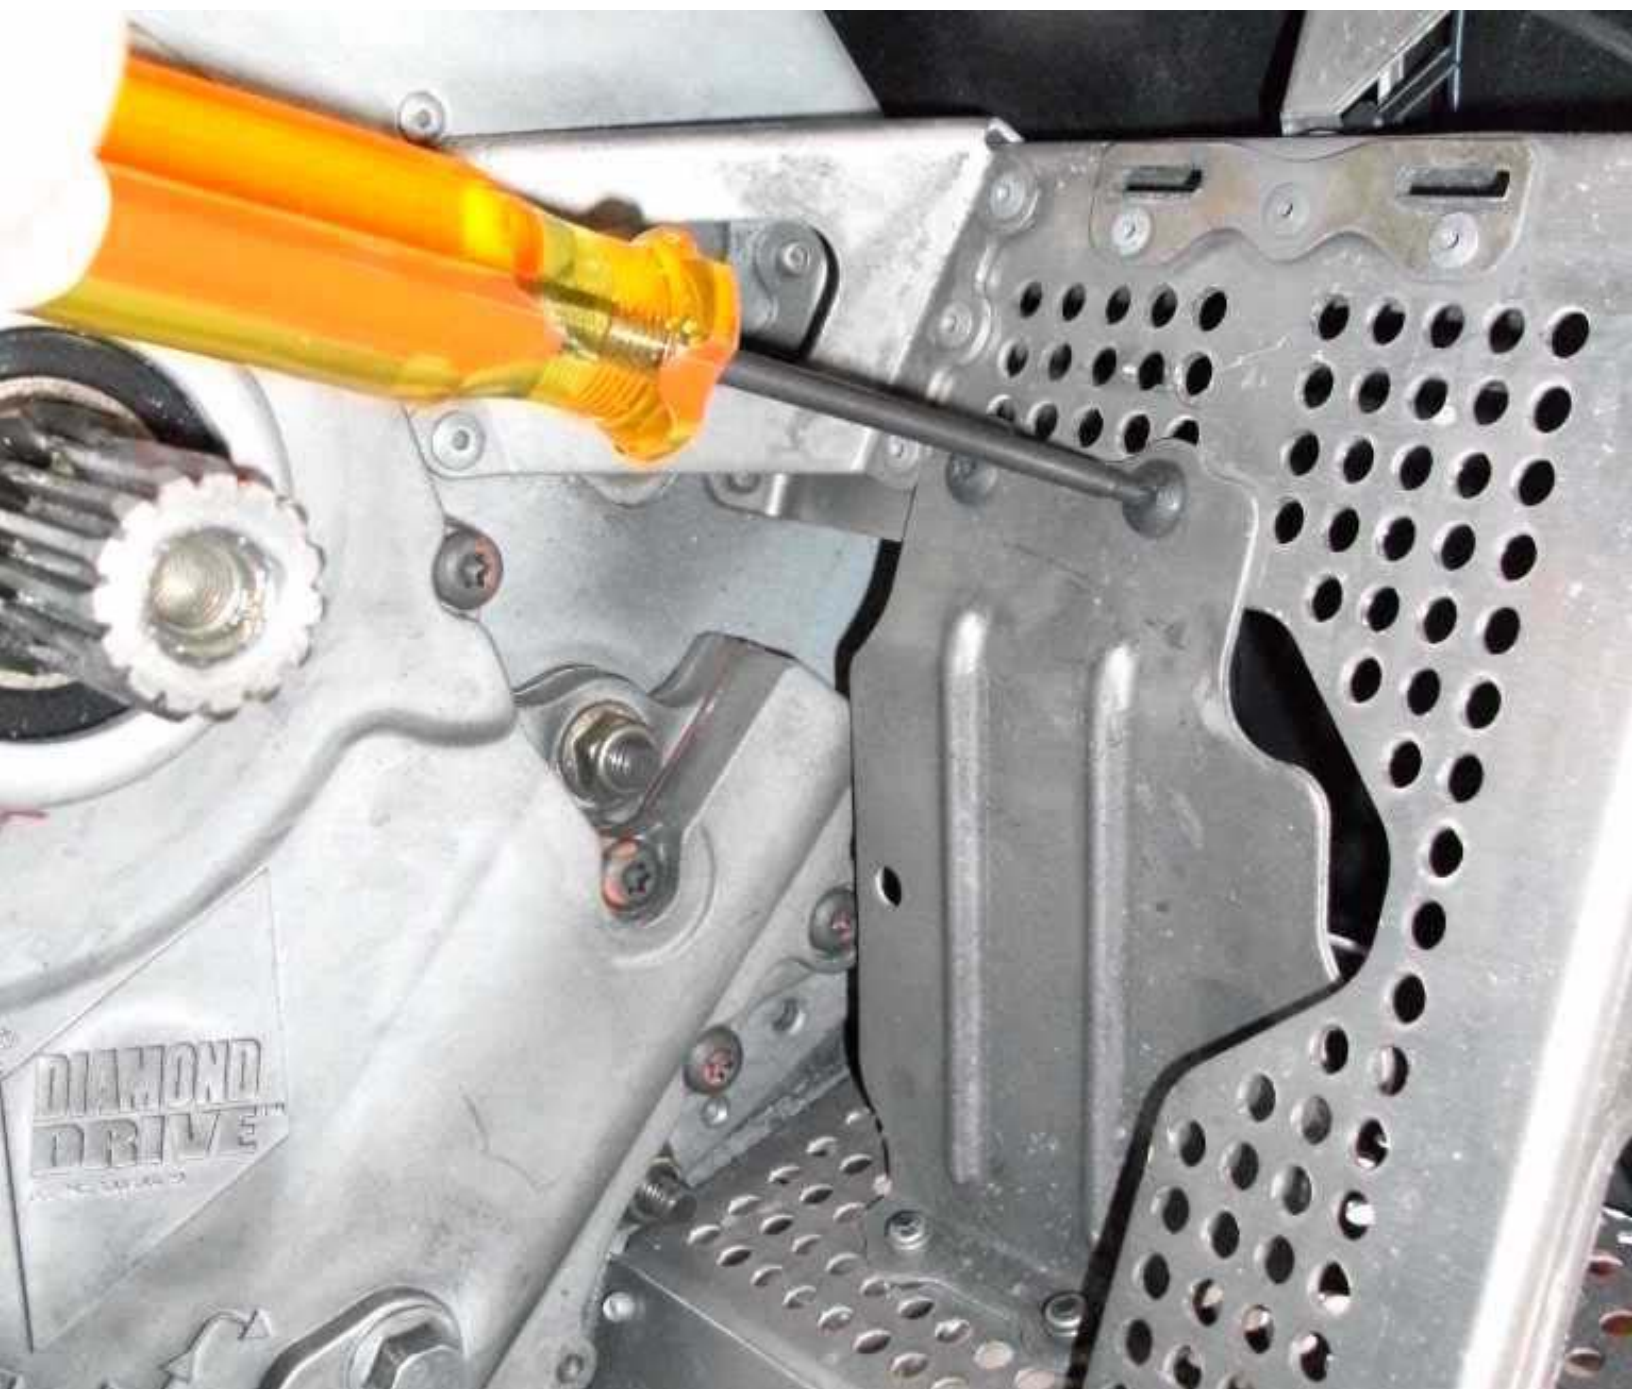
Removed foot pocket brace. Four T-20 torx screws.

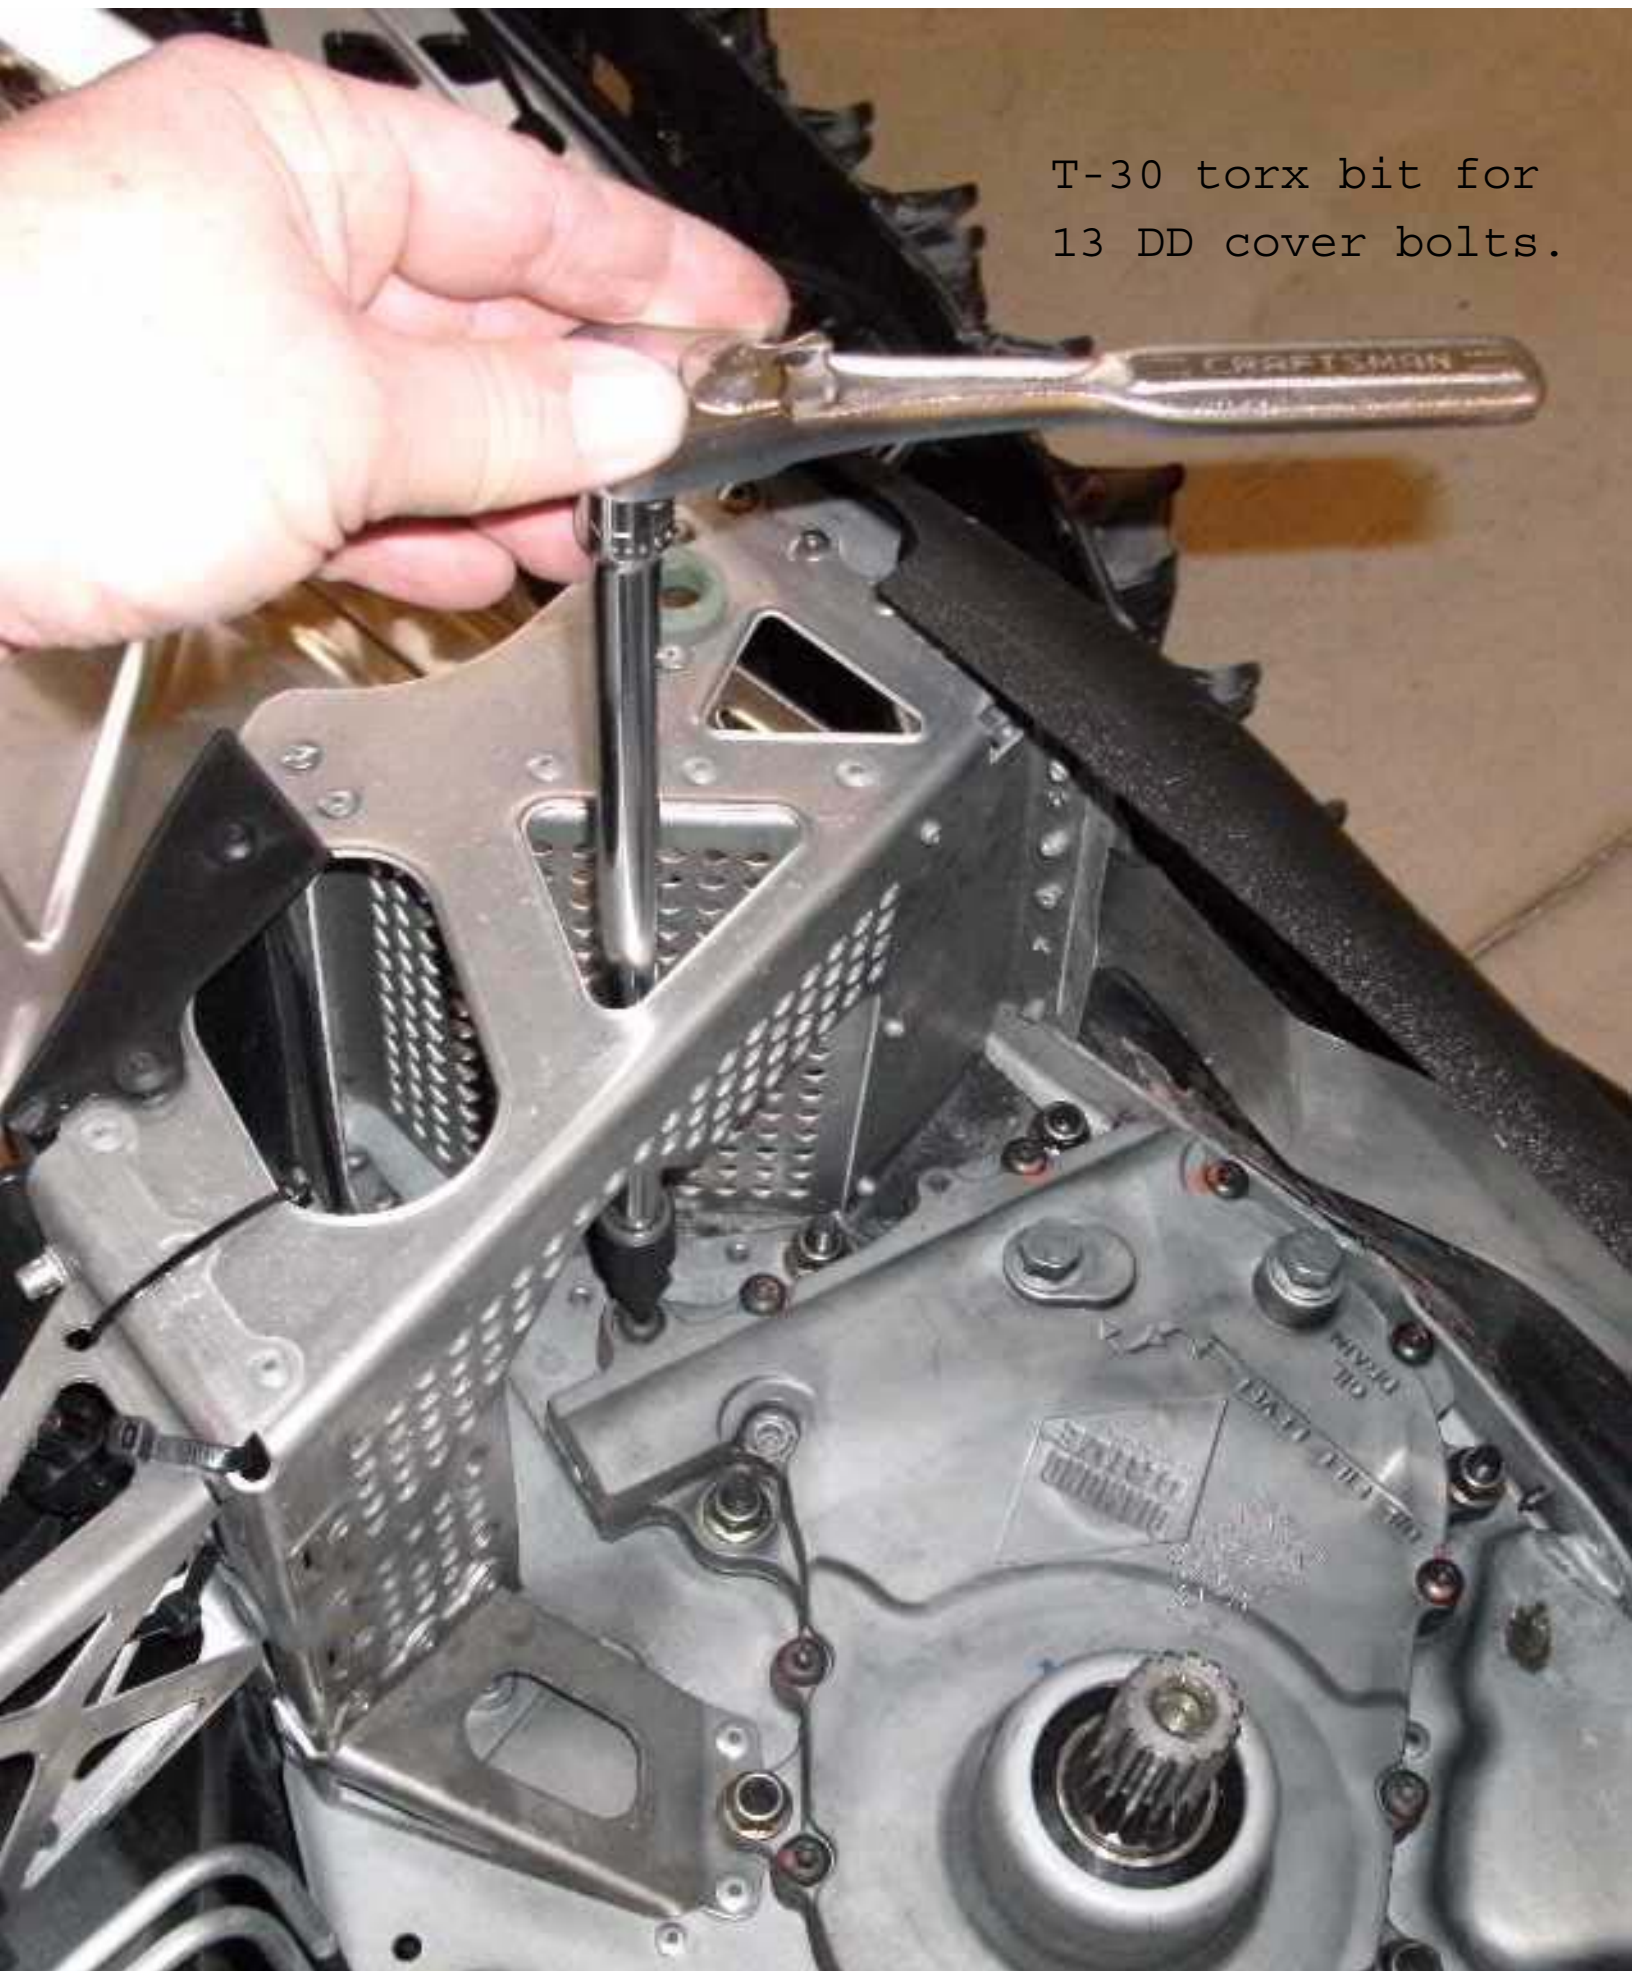
T-30 torx bit for  
13 DD cover bolts.

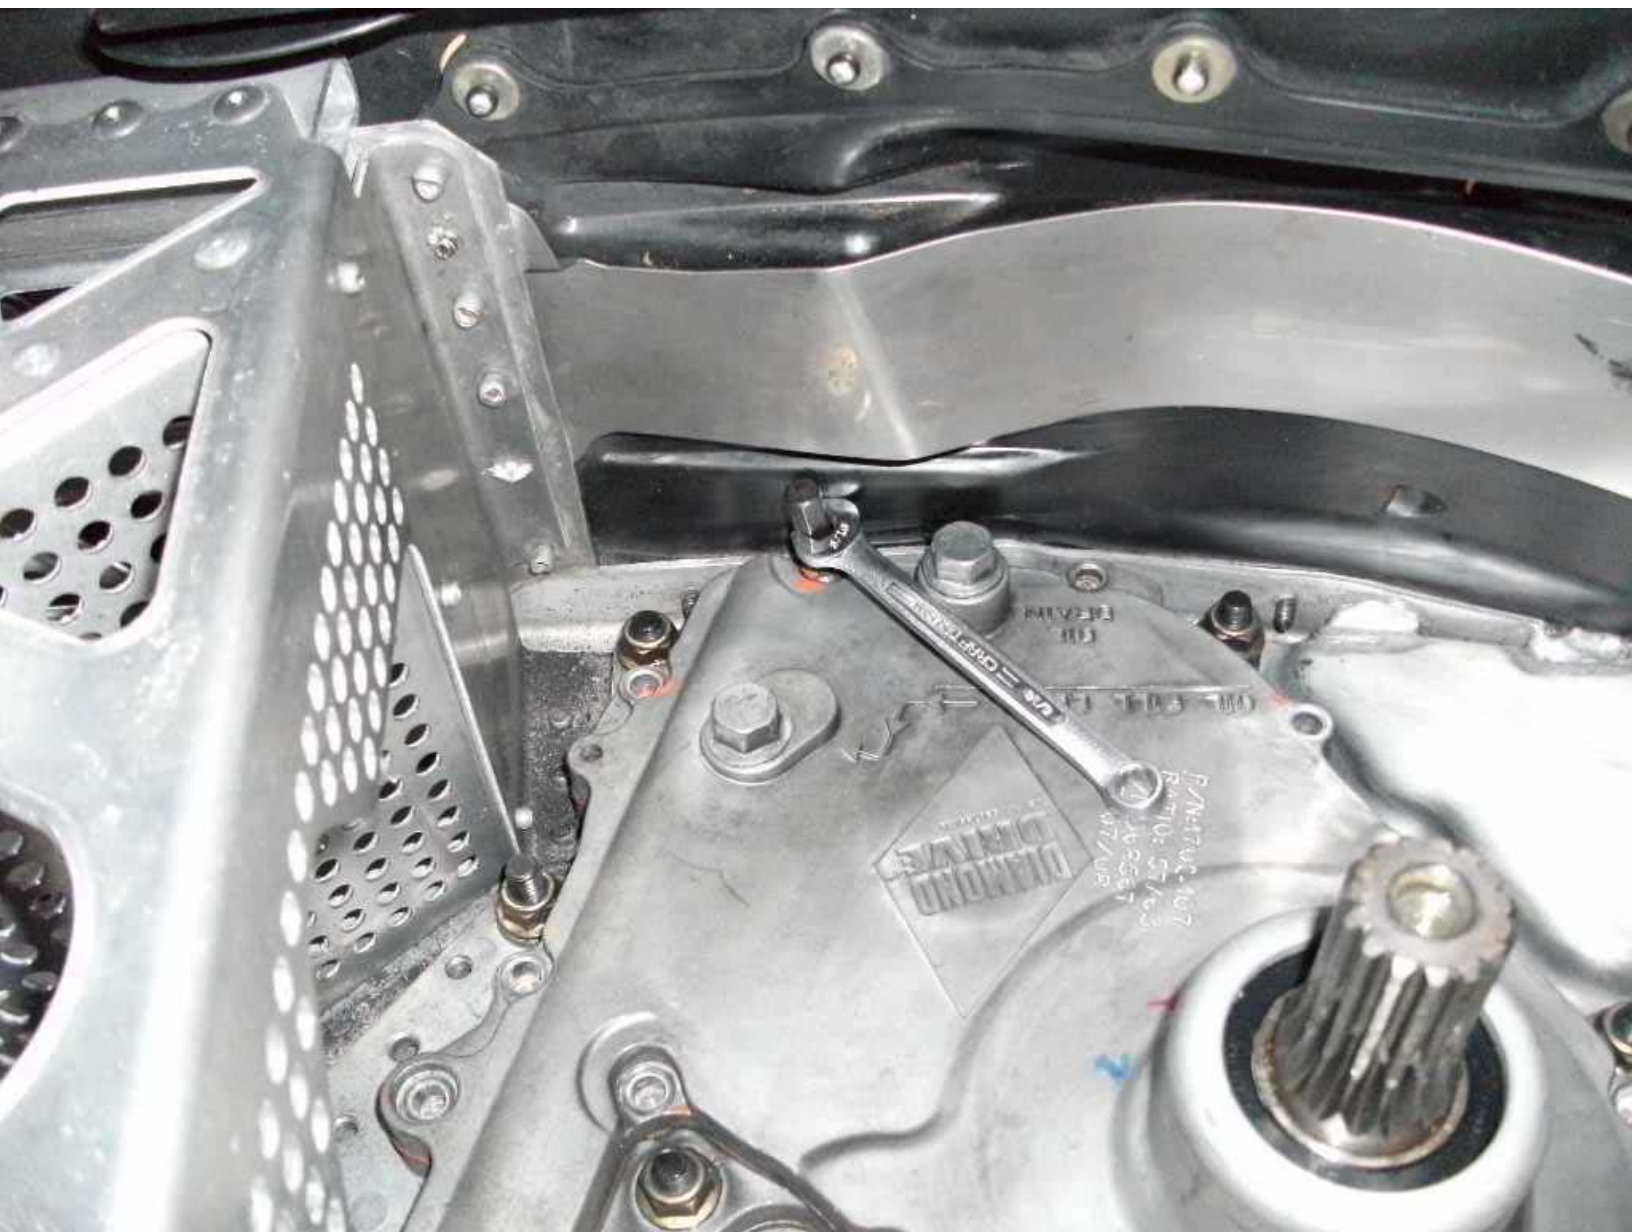
One cover bolt is impossible to get at with a ratchet. Had to use the T-30 bit with a 5/16" wrench. The rest were easy.

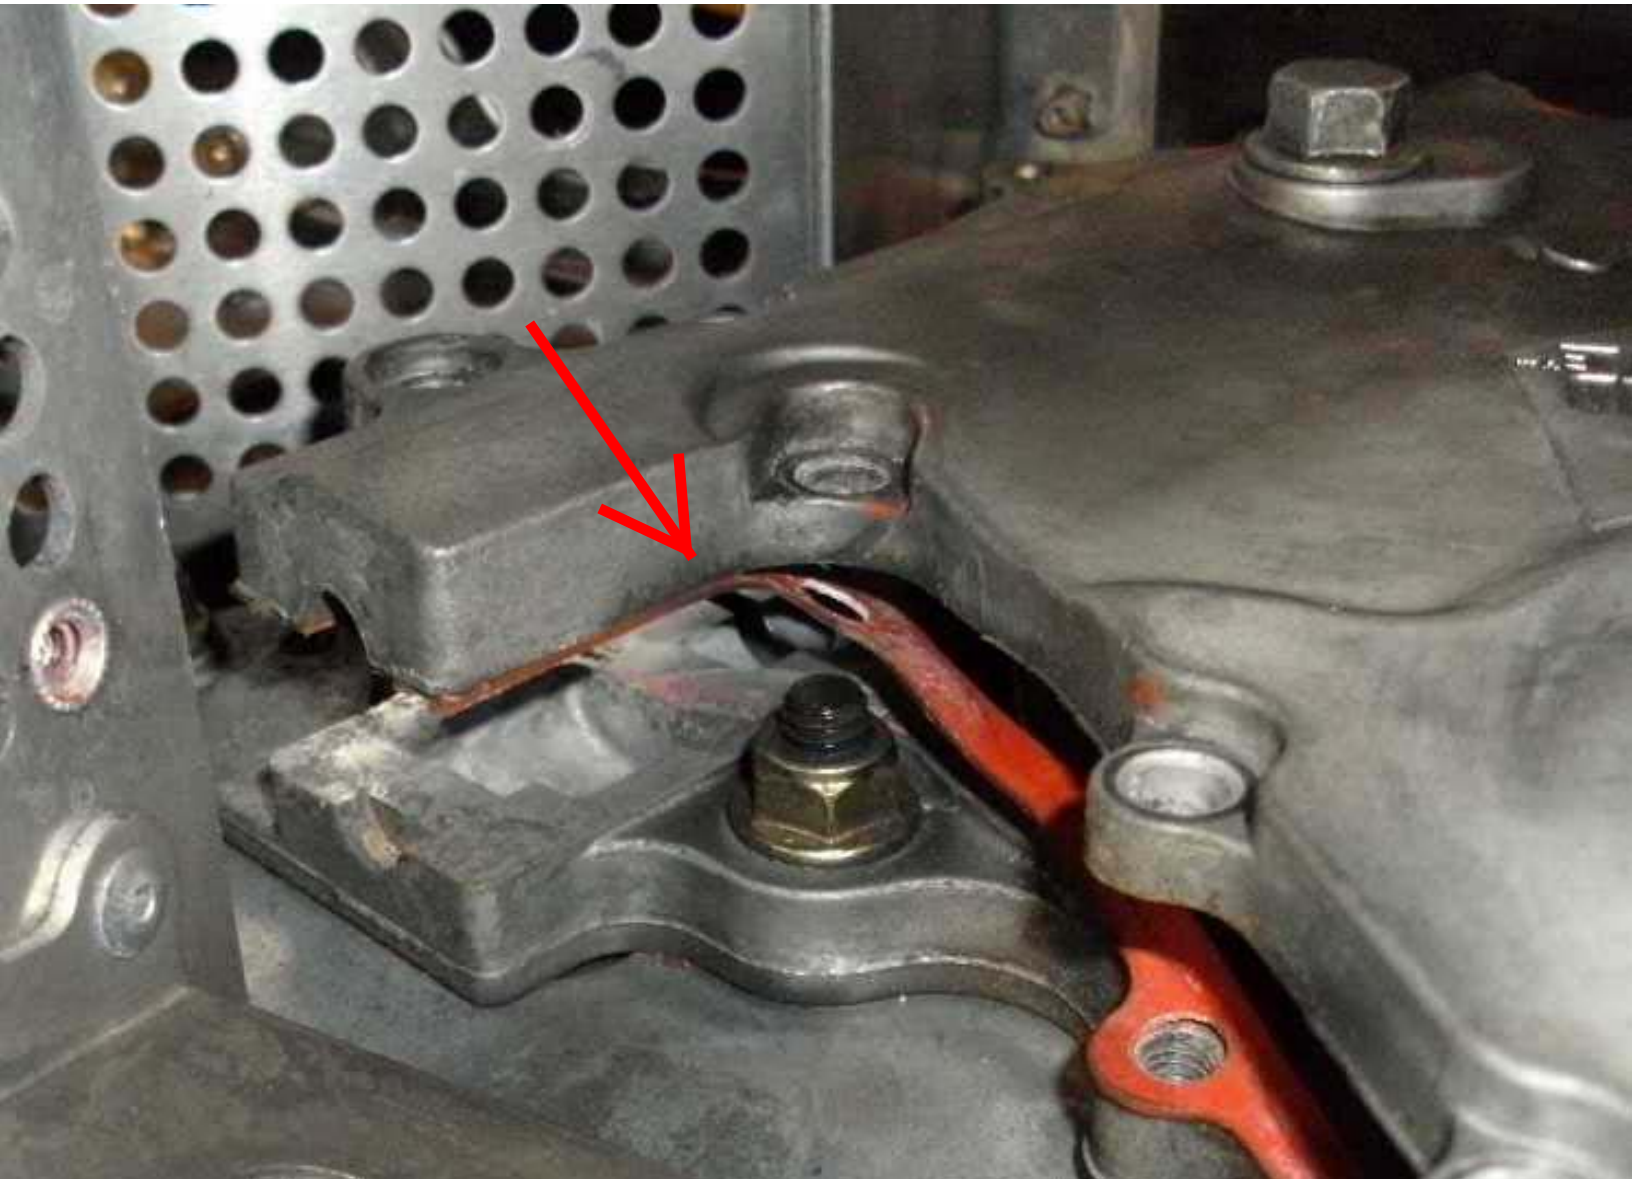
Grabbed the drain plug with a vice-grip and the secondary clutch shaft in my other hand. Wiggled the cover loose by hand. Easier than I expected. Was careful not to tear the gasket! Gasket popped loose with some TLC from a small screw driver.

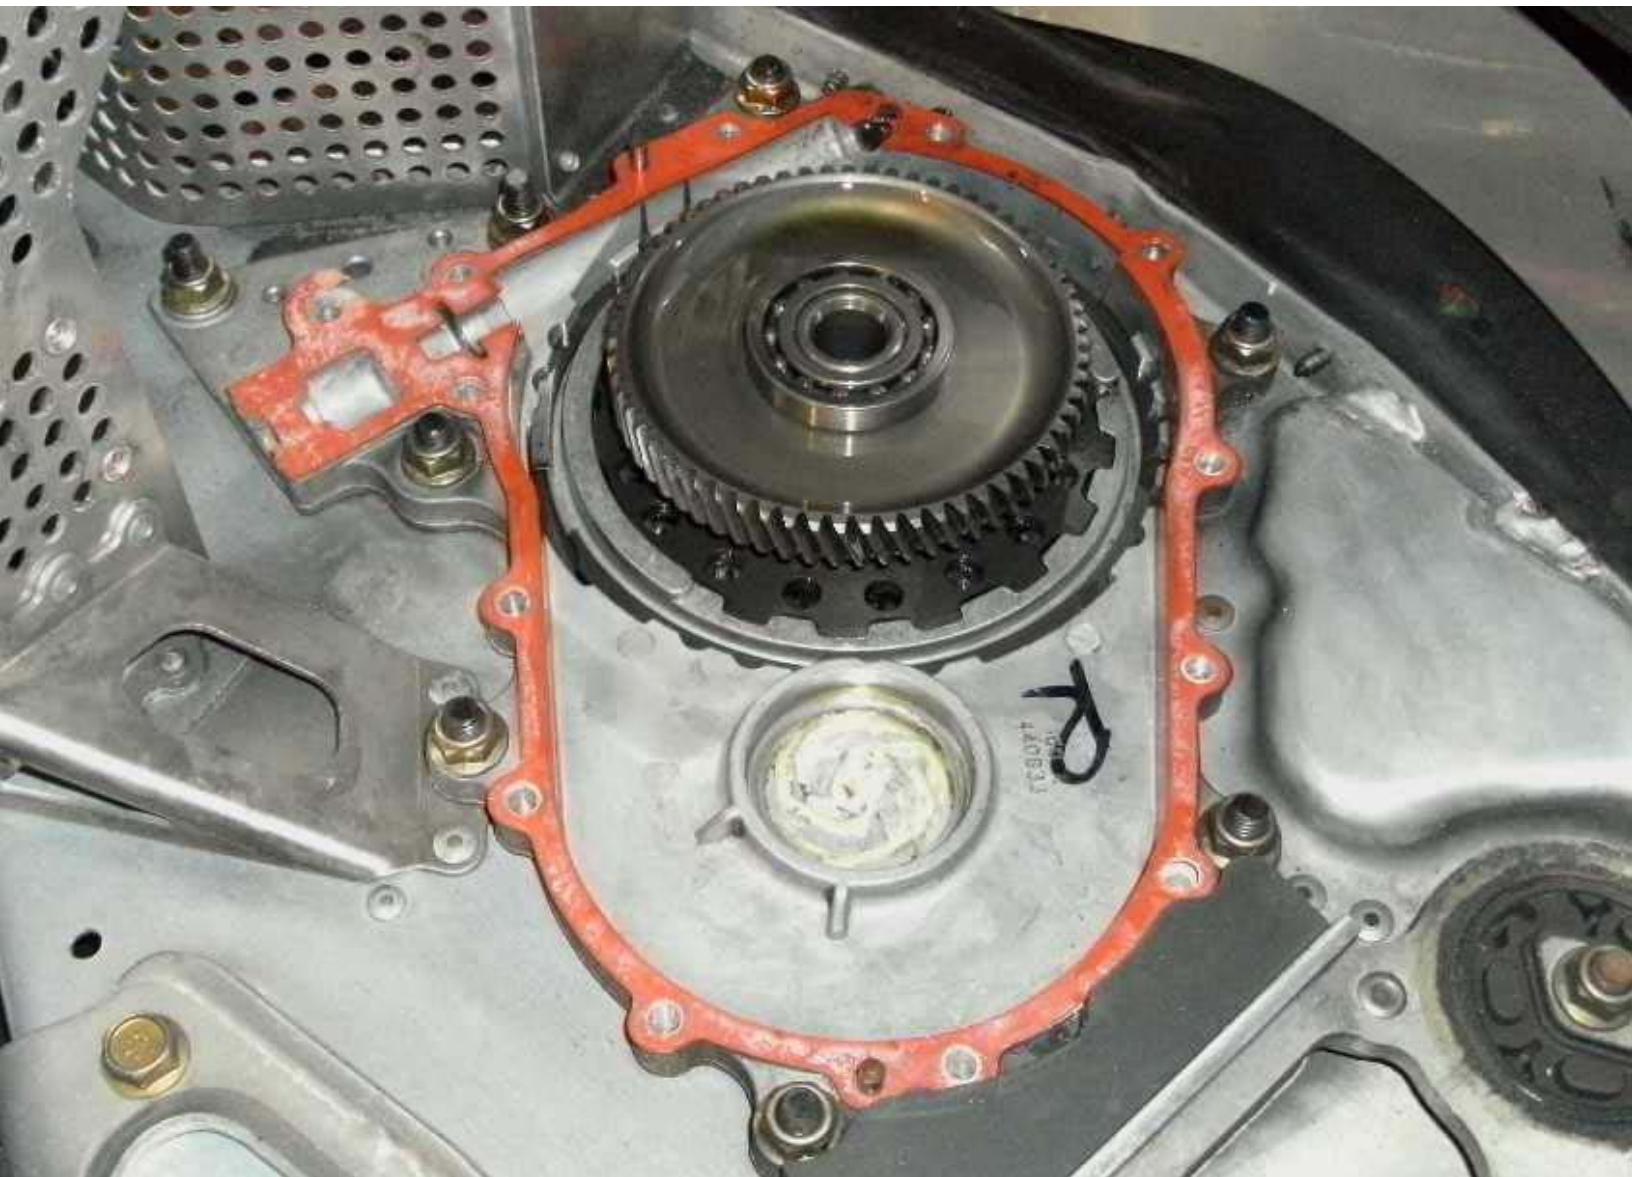
This is what it looks like with the cover removed. The transfer shaft will wiggle free by hand and pull straight up and out - fairly easy. The bad bearing is on the other end of the transfer shaft.

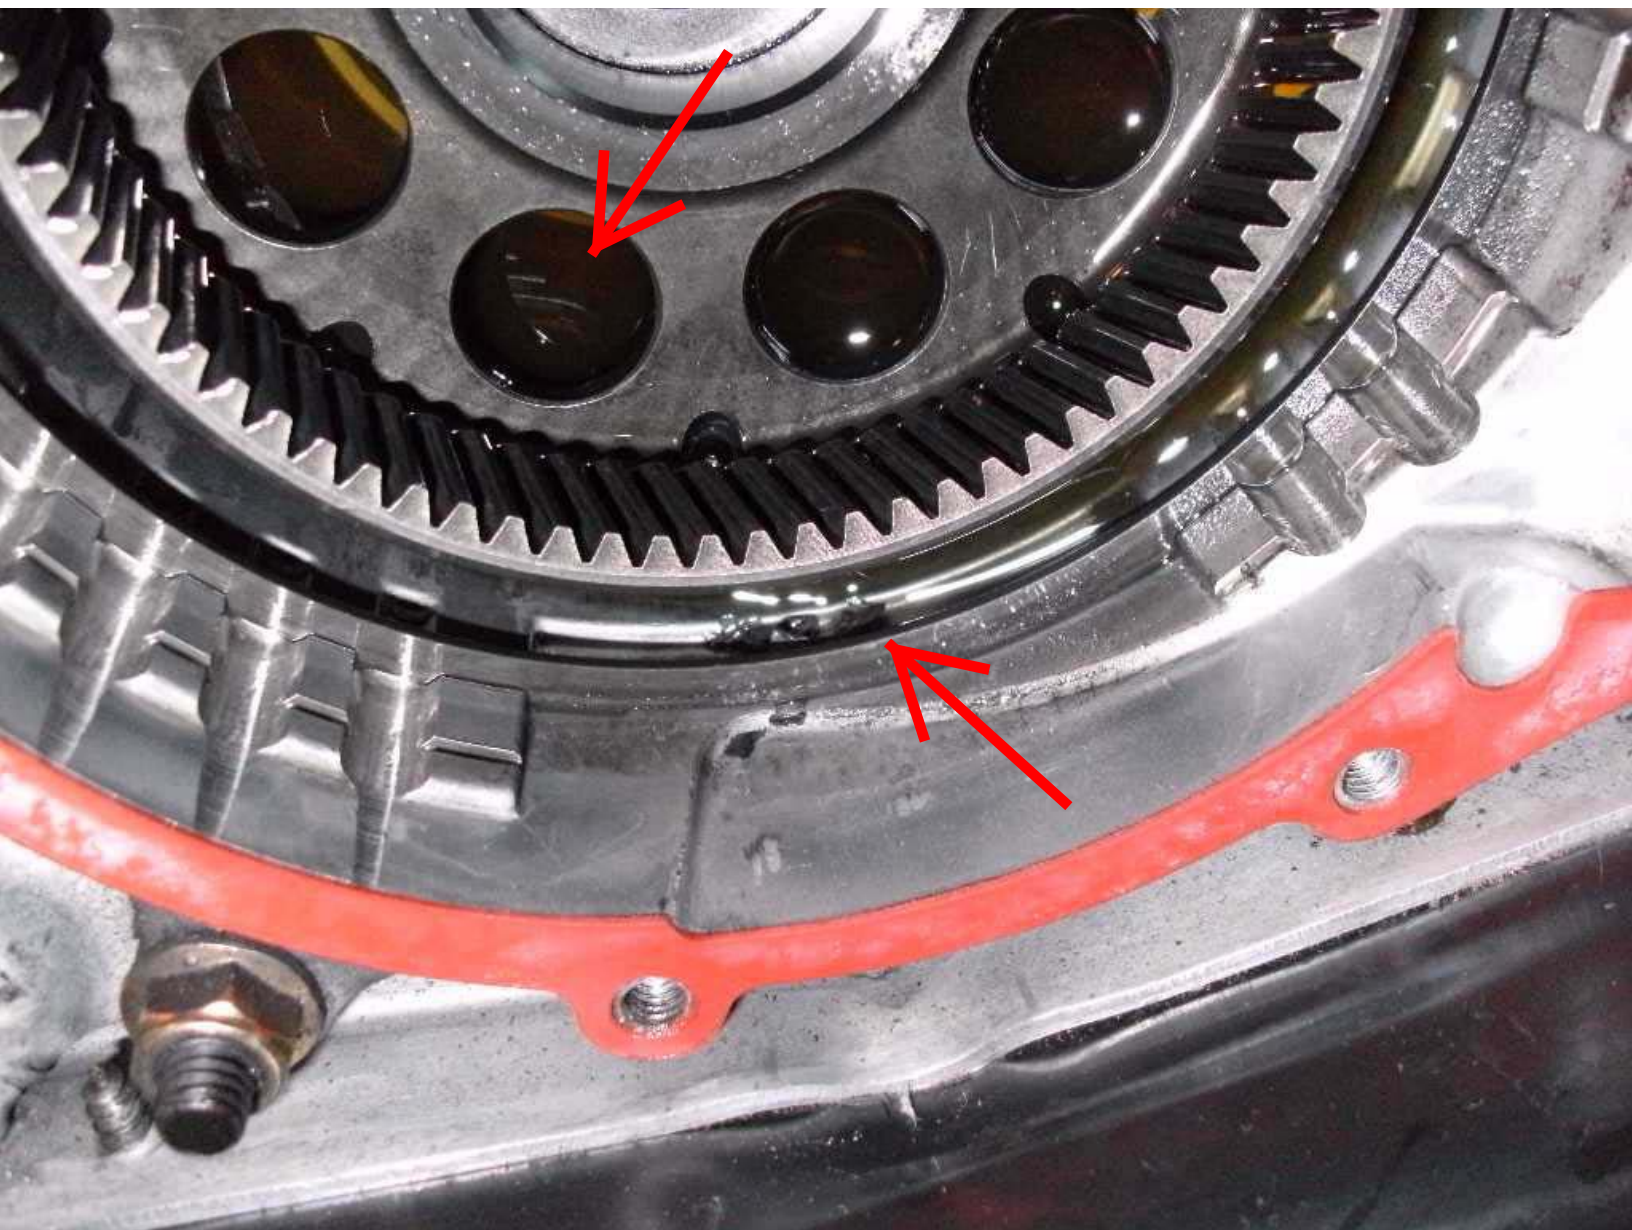
Shrapnel in the DD case!! Removed 2nd snap ring and fished crap out with a magnet. Also through the holes in the drive shaft basket. The DD oil is new and clean. Plan to run it one ride and then flush with fresh oil.

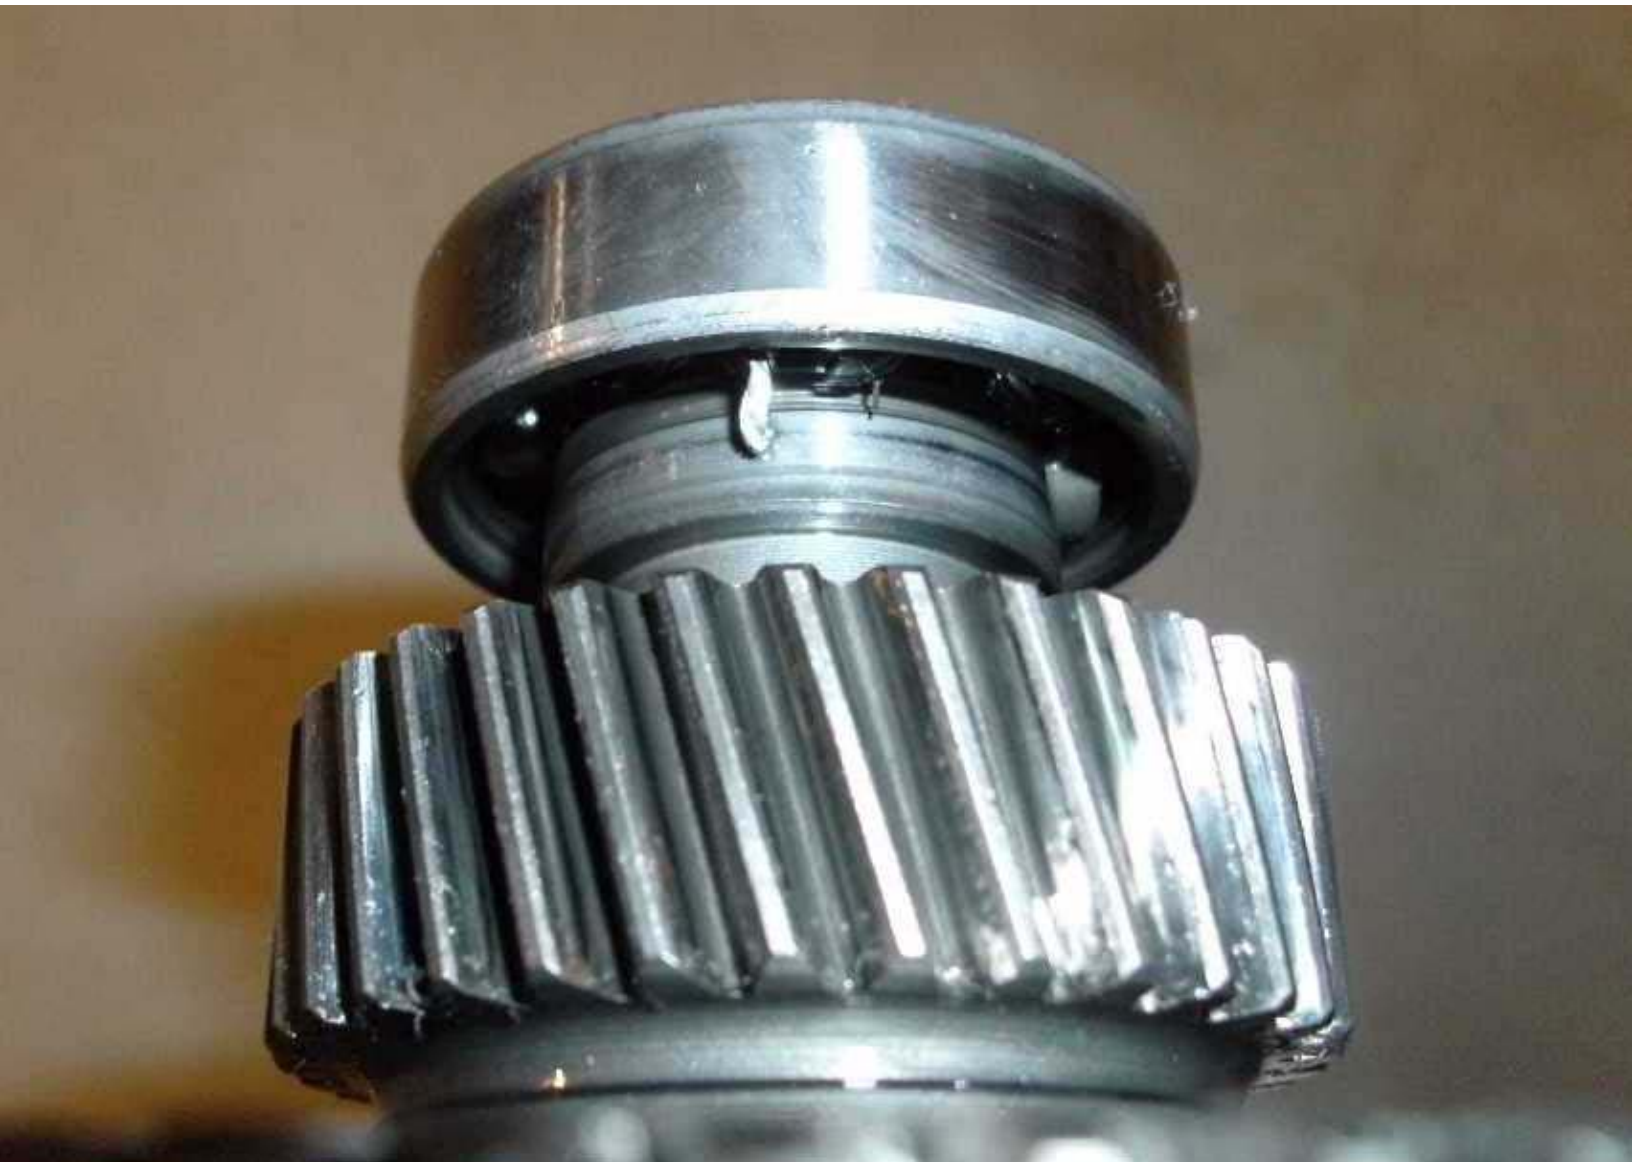
Bad (stock) 6203 bearing, after 600 miles. Cage is half gone. Inner seal popped out and the other seal was twisted. The balls and both races were tight and spun very smooth. Did thrust loads put heavy loads on the cage? Or was the cage just cheap, poor quality, CRAP ??

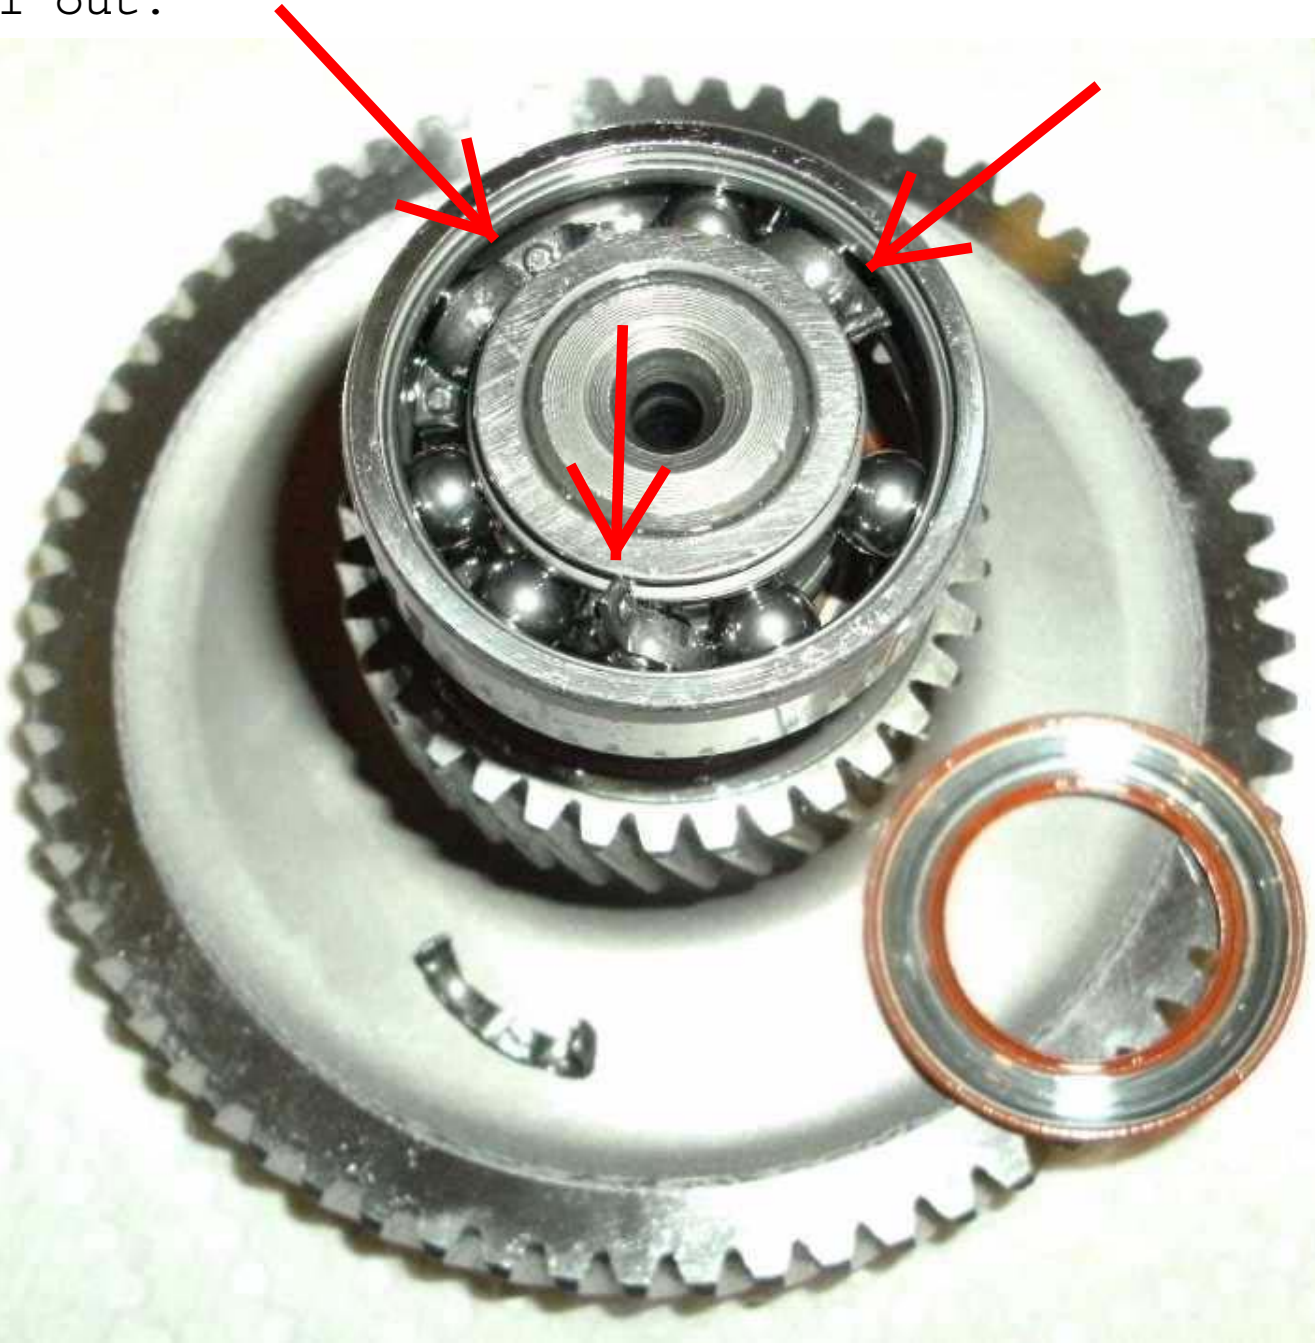
Portions of the cage remained in the bearing, surrounding three of the balls. The loose piece of cage was also in the bearing, held in by the seal. The outer seal was in place, until I popped it off with a screwdriver. Then the loose piece of cage fell out.
