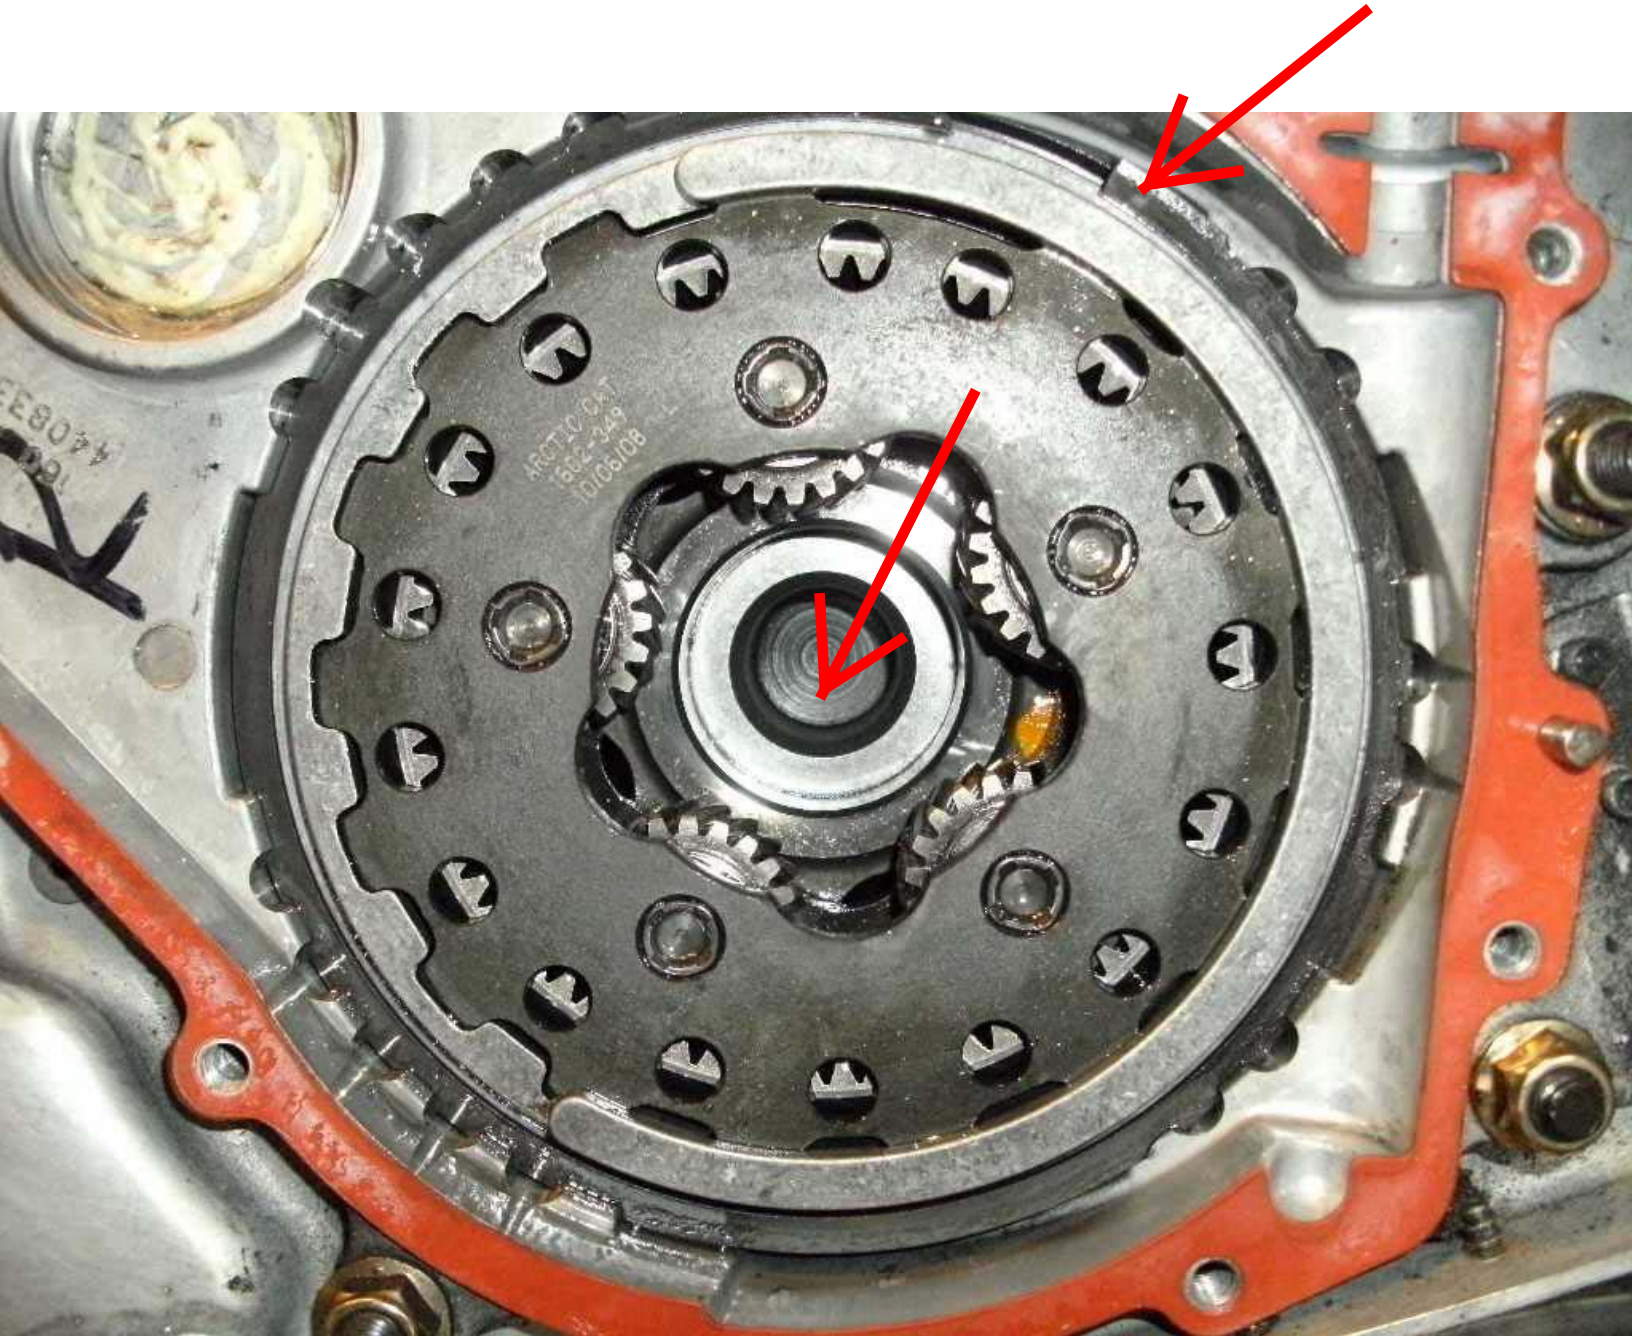
The center hole in the output drive shaft was full of metal filings, cleaned with an oily paper towel. Note the end of the snap ring - easy to pop out with a small screwdriver.

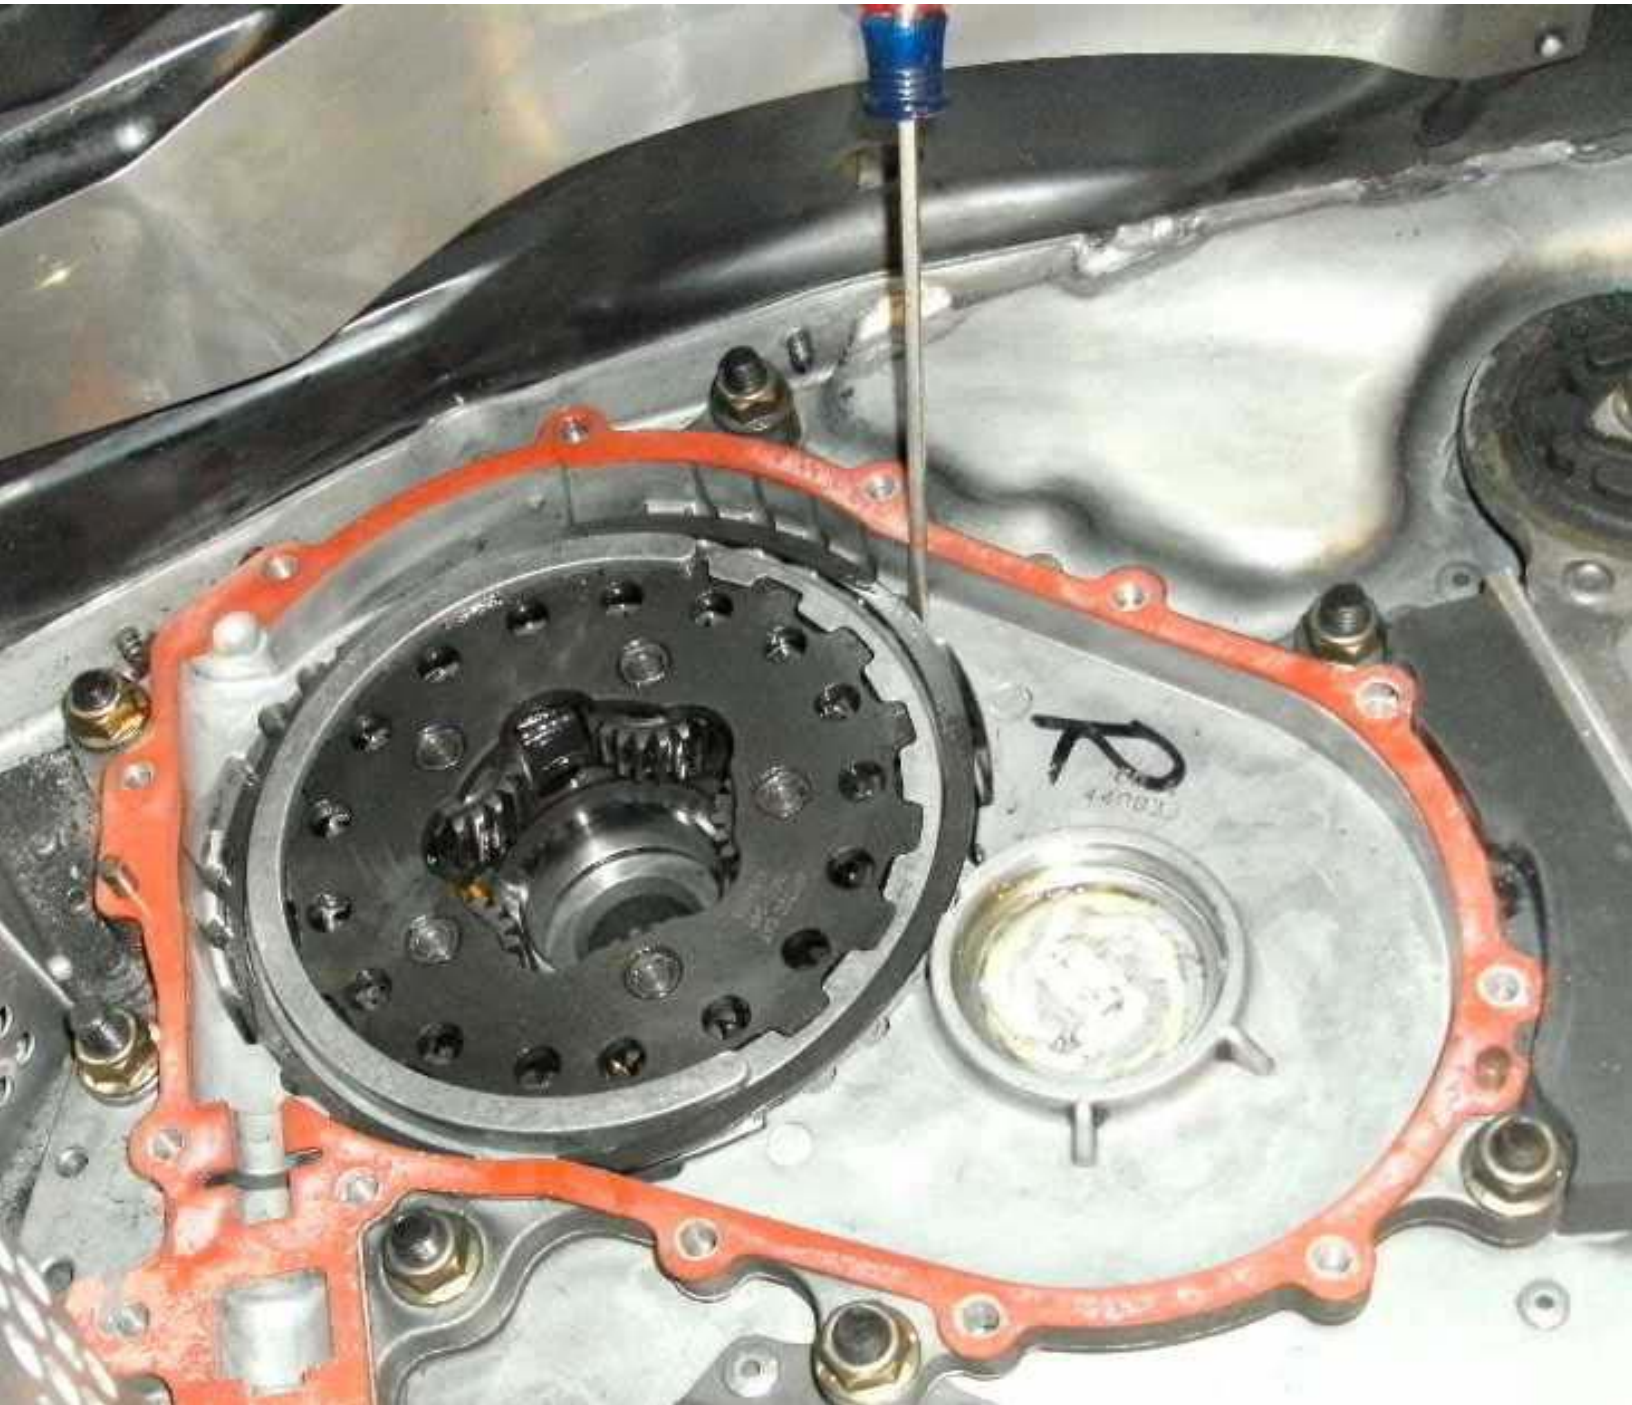
Easy to pop the snap ring out with a small screwdriver. Then the planetary basket easily lifts out by hand.

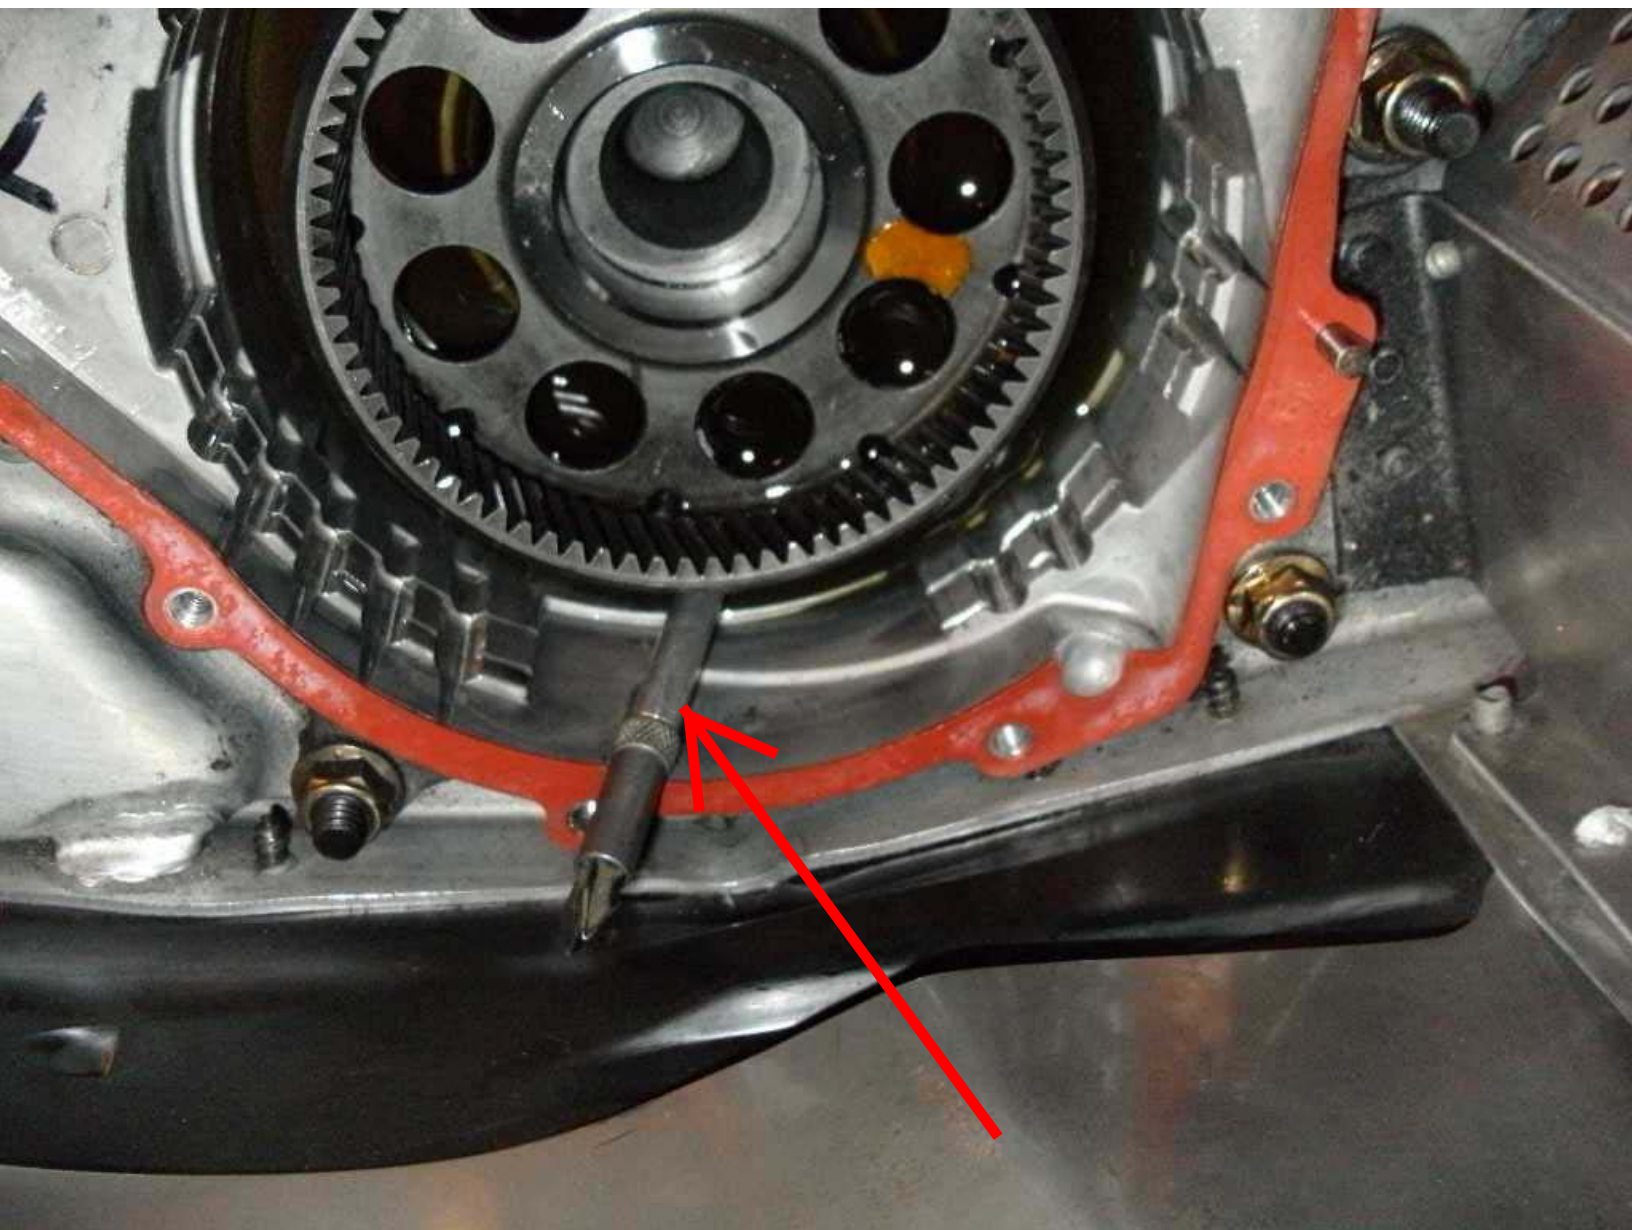
A magnet easily grabbed loose metal parts and debris from the bearing cage. Wiped out every thing with clean paper towels - sludge and small metal flakes.

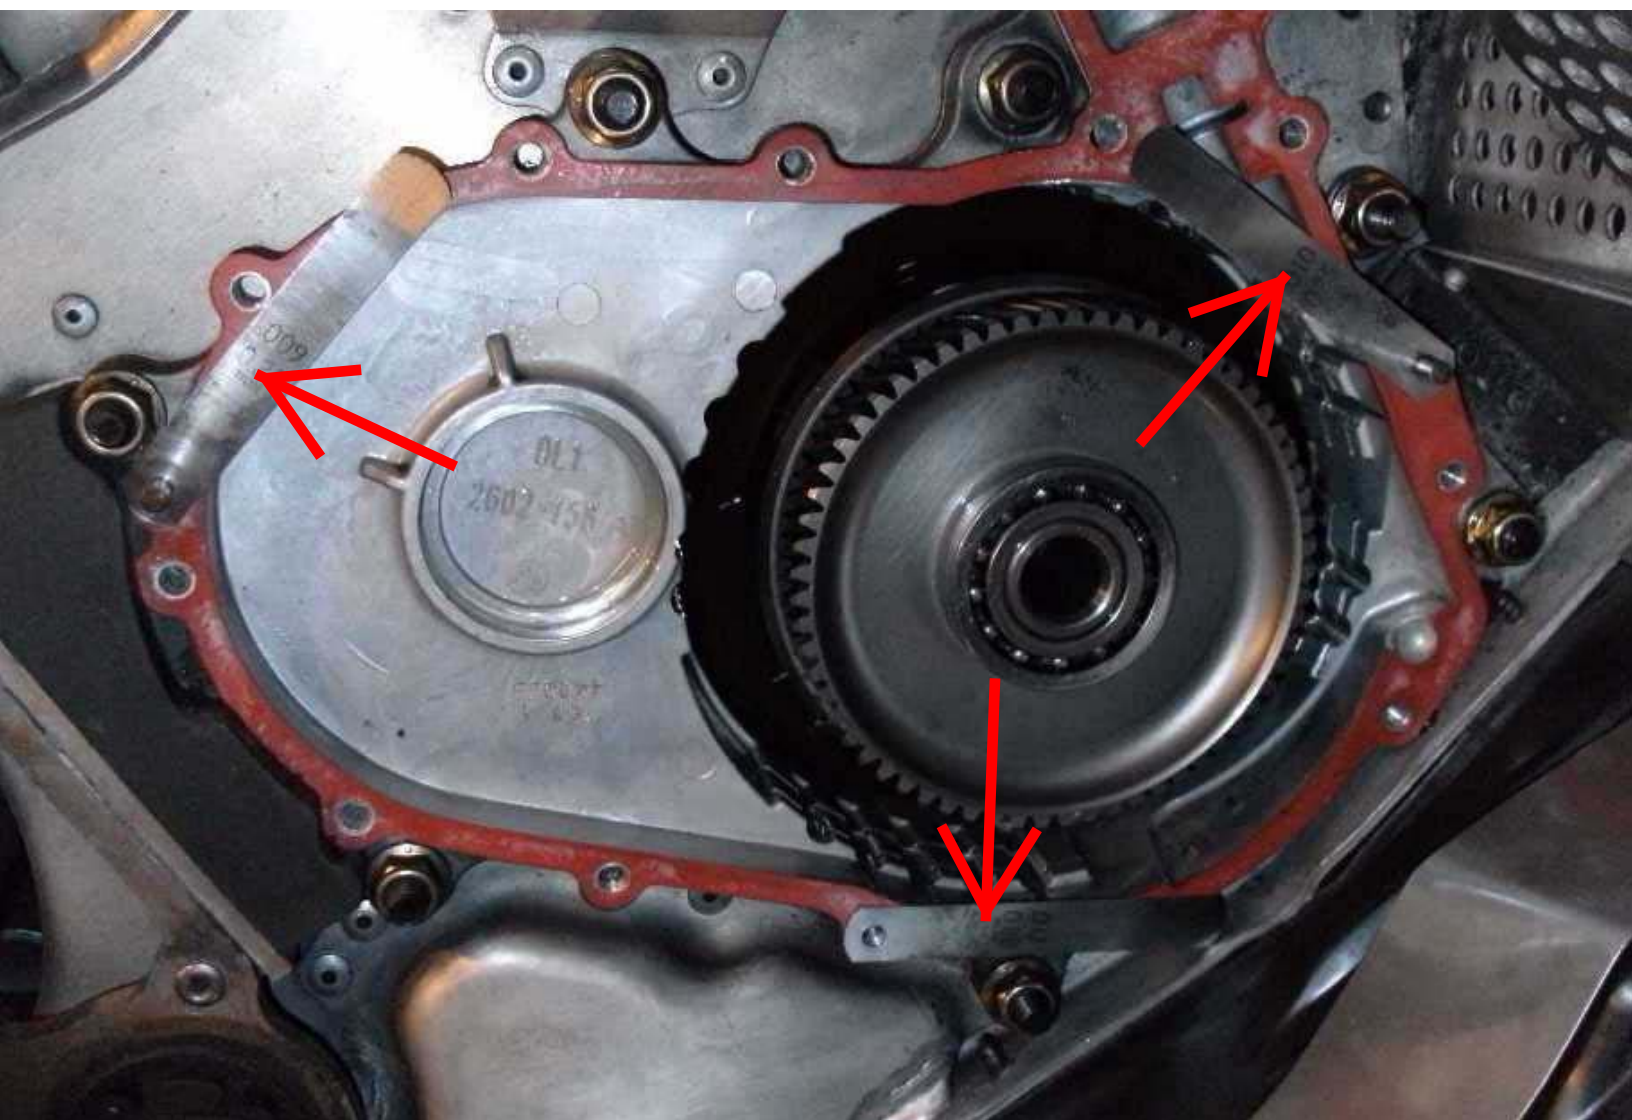
Measured the transfer shaft length by putting three feeler gauges under the cover and checking when the rocking stopped. My transfer shaft is about 0.016" too long (with the stock spacer and bearing). Would be 0.014" worse with the wider 5203 bearing.

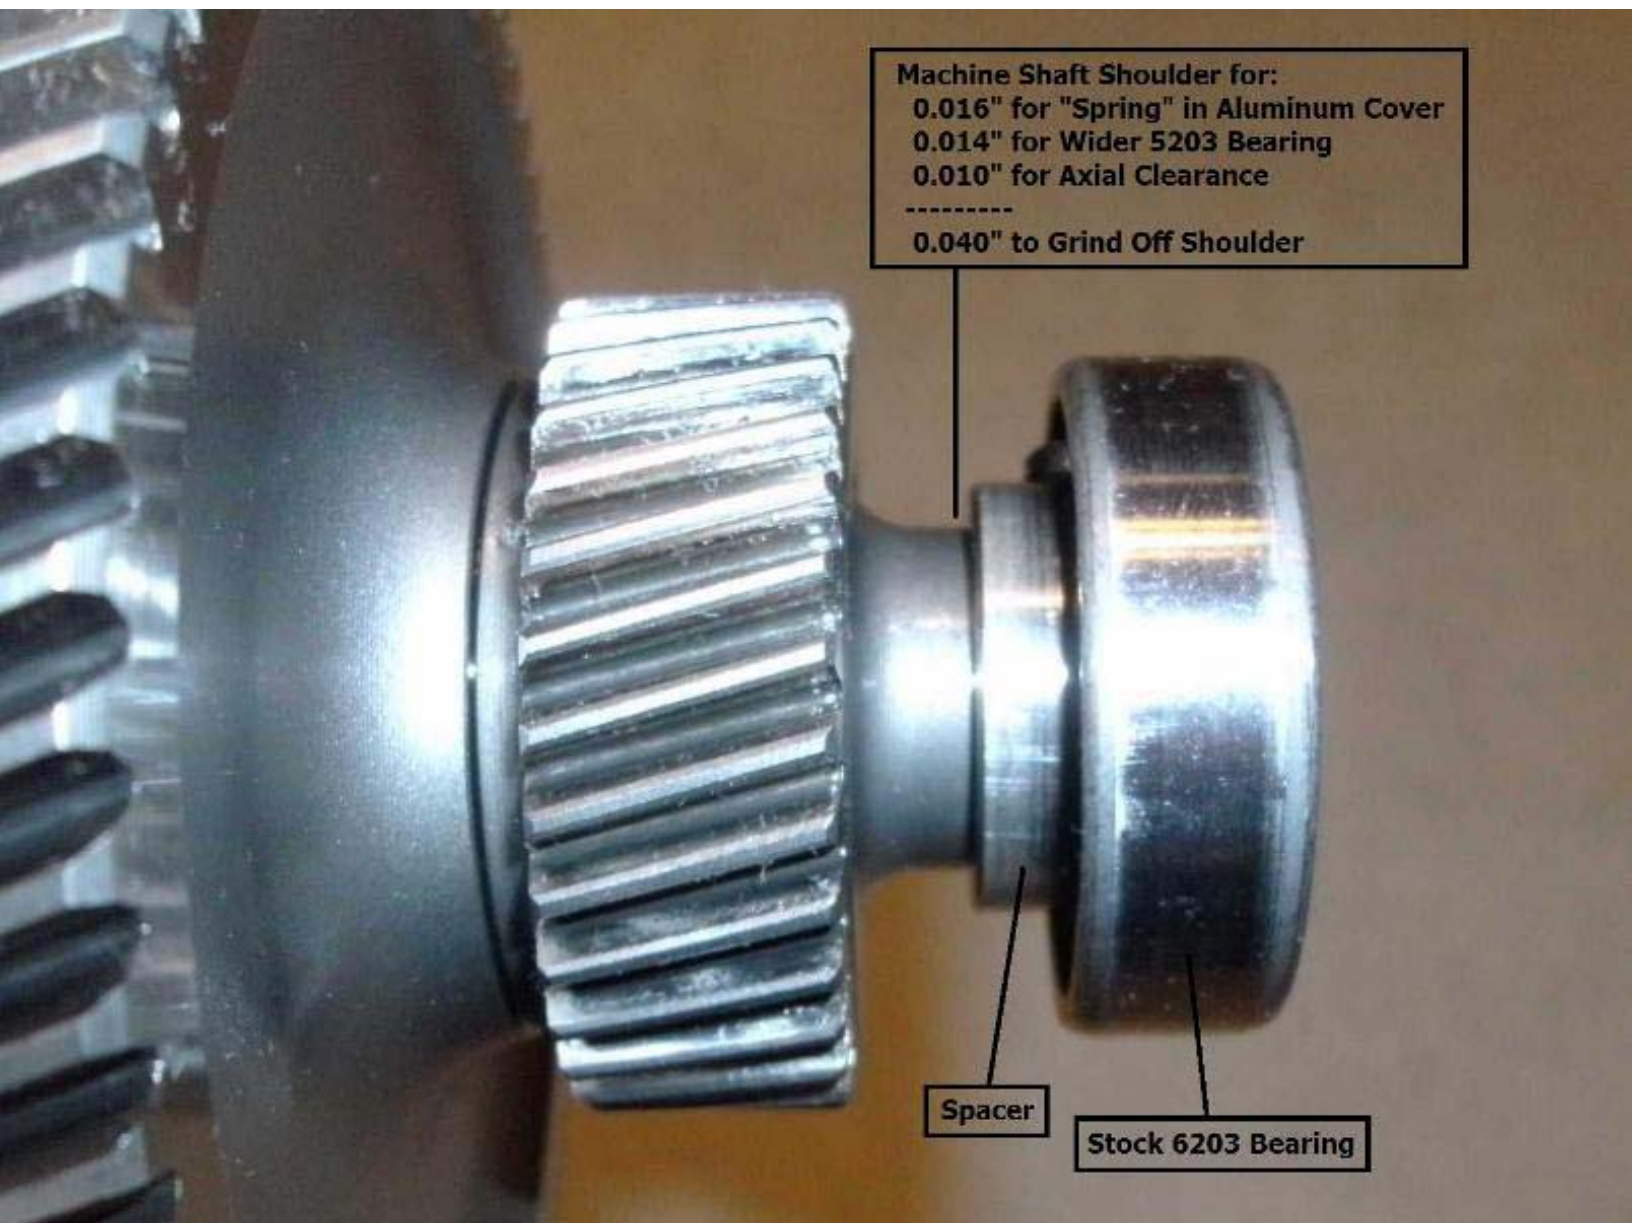
My transfer shaft stuck past the end of the 6203 bearing by only 0.014". Some guys say it should be 0.050". Maybe the shafts were made with poor dimensional accuracy on their length? My shoulder looks like it extends further out on the shaft, as compared to other photos from other machines.

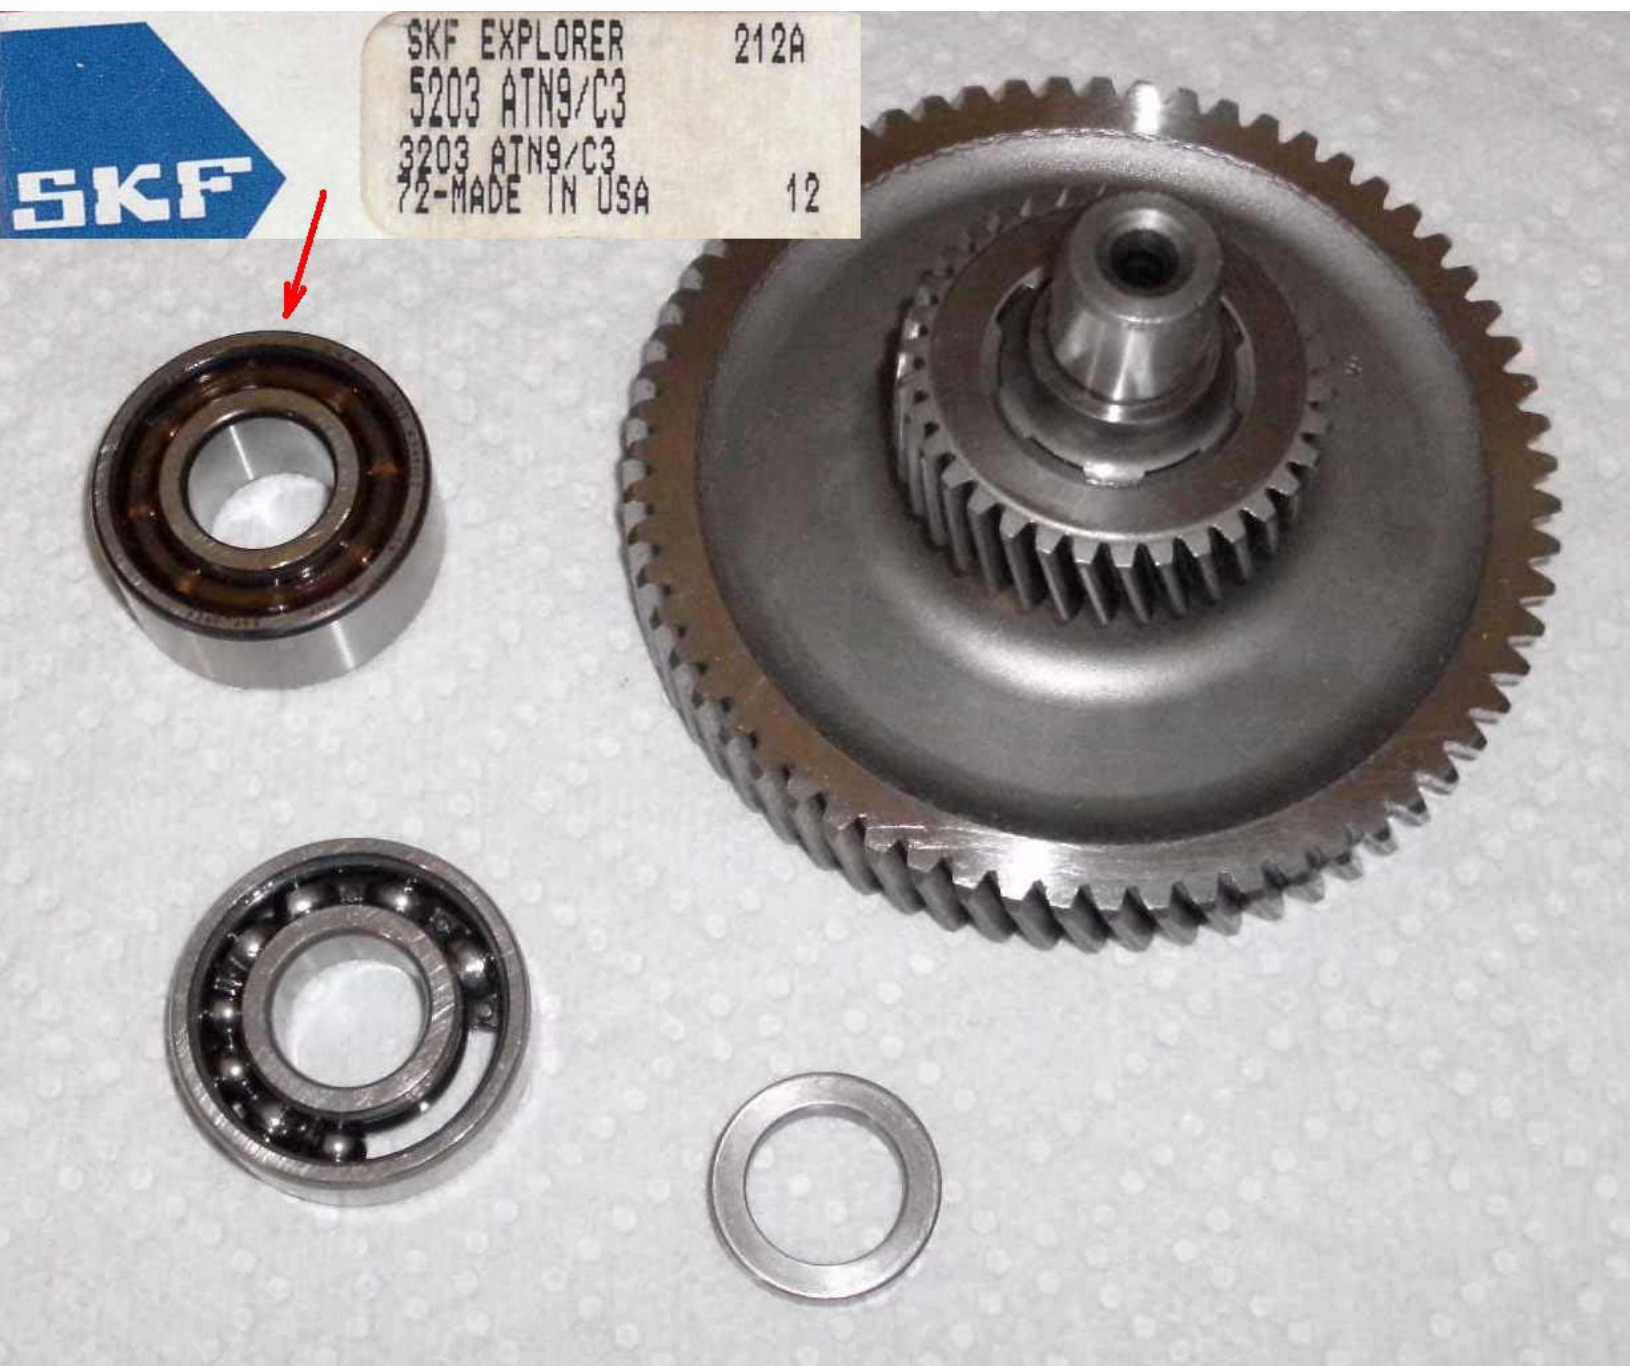
Stock 6203 bearing (0.472" thick) with damaged race.  
Stock spacer (0.202" thick).

New SKF 5203(3203)ATN9/C3 Explorer bearing (0.688").

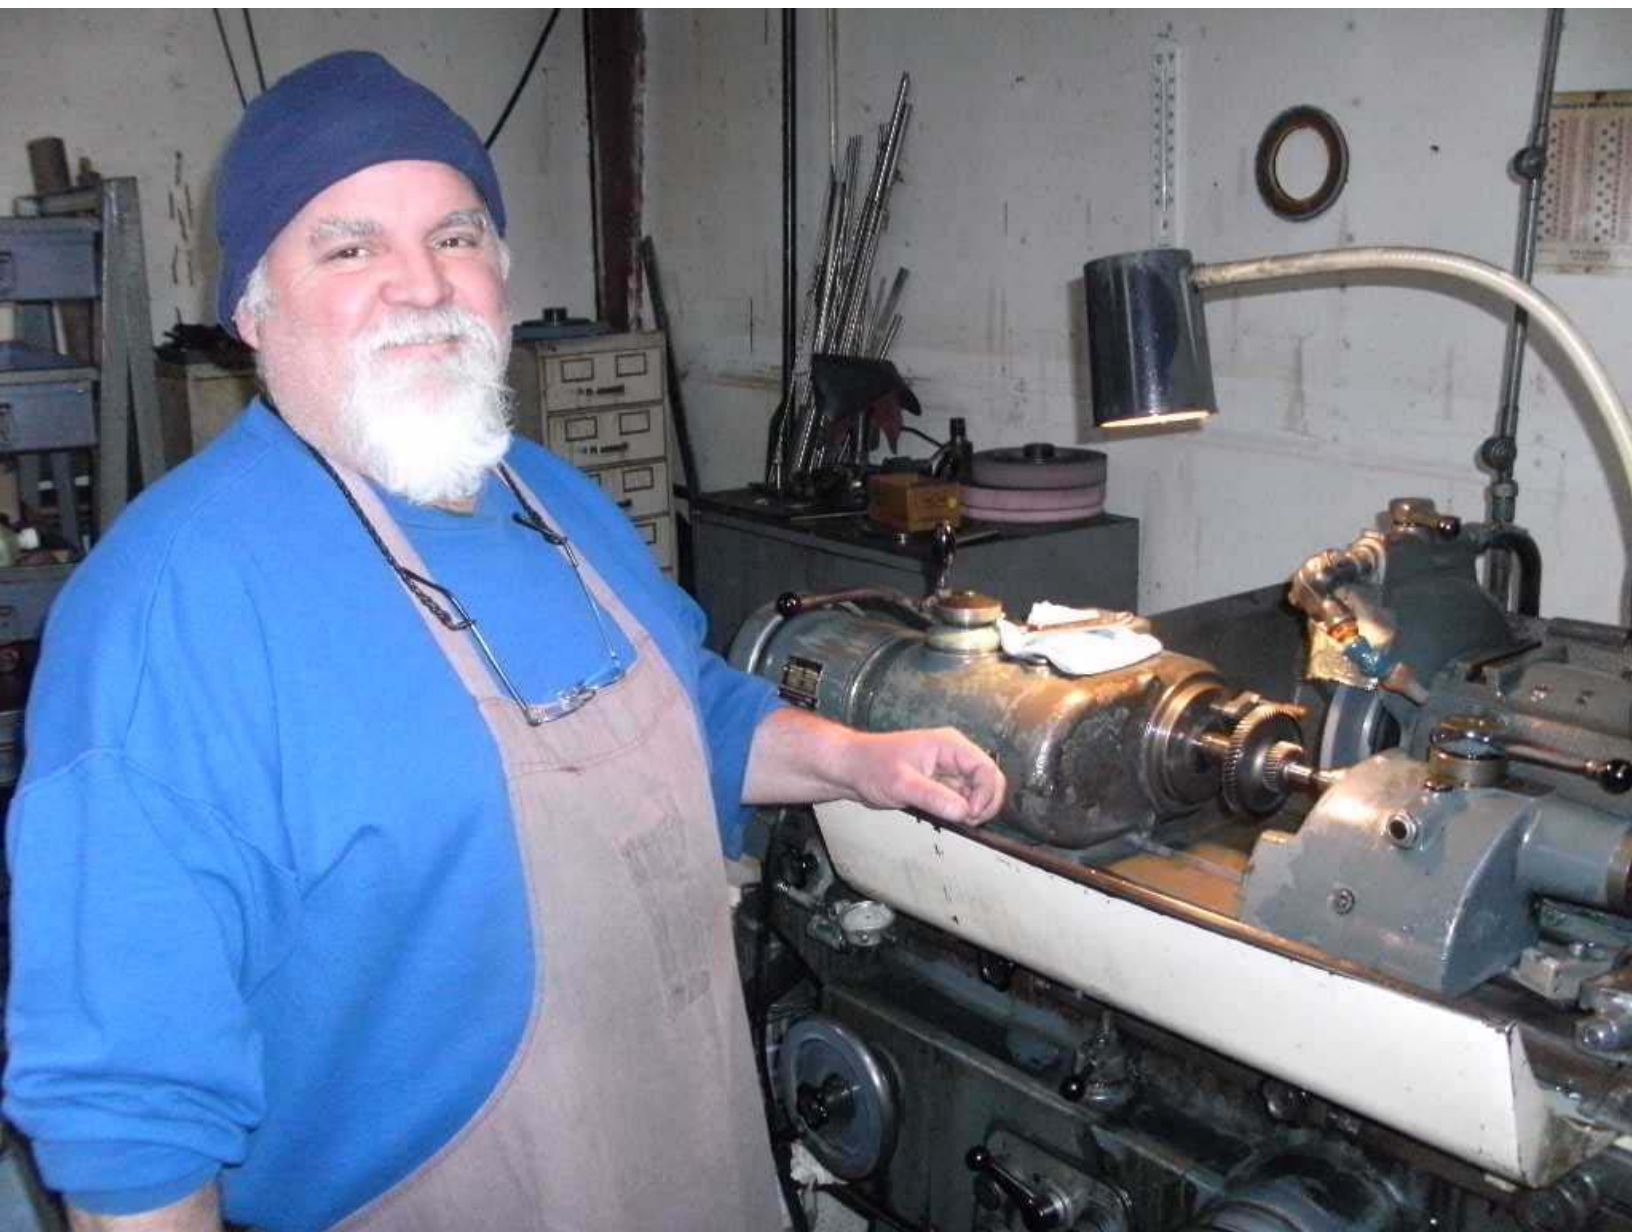
This is Doug from A&J Grinding. His family has been doing precision grinding for many years. Does lots of hard shafts for bearing fits. That's my shaft in his machine. Very smart and nice guy. Did a beautiful job for \$50, completed the same day.

His grinding machine (one of many) is dual centered and liquid cooled. He dresses the stone to cut only on the corner. Doug matched the shaft size, without touching the original shaft surface and moved the shoulder back exactly 0.040". He's a precision guy.

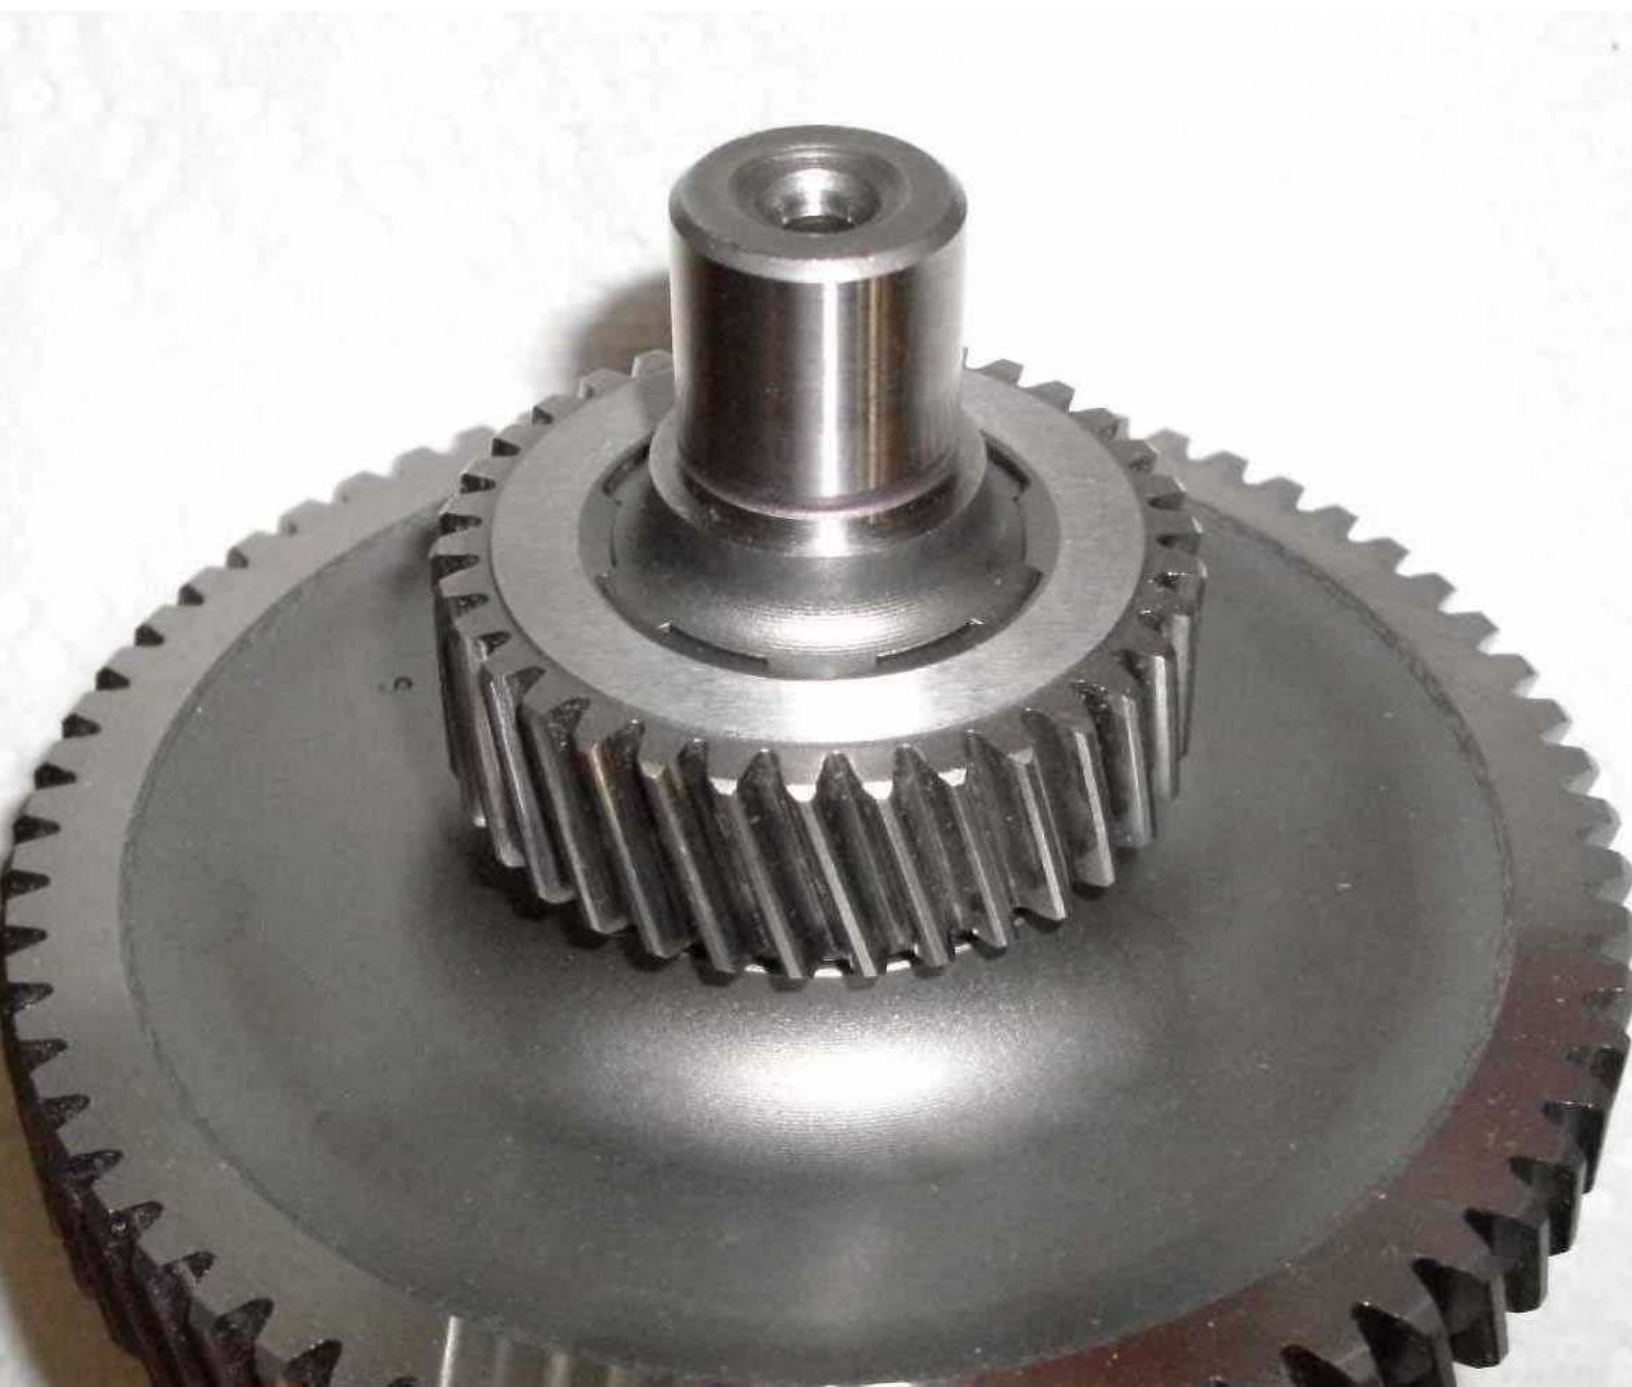
Undercut at  
the end of  
the original  
shaft

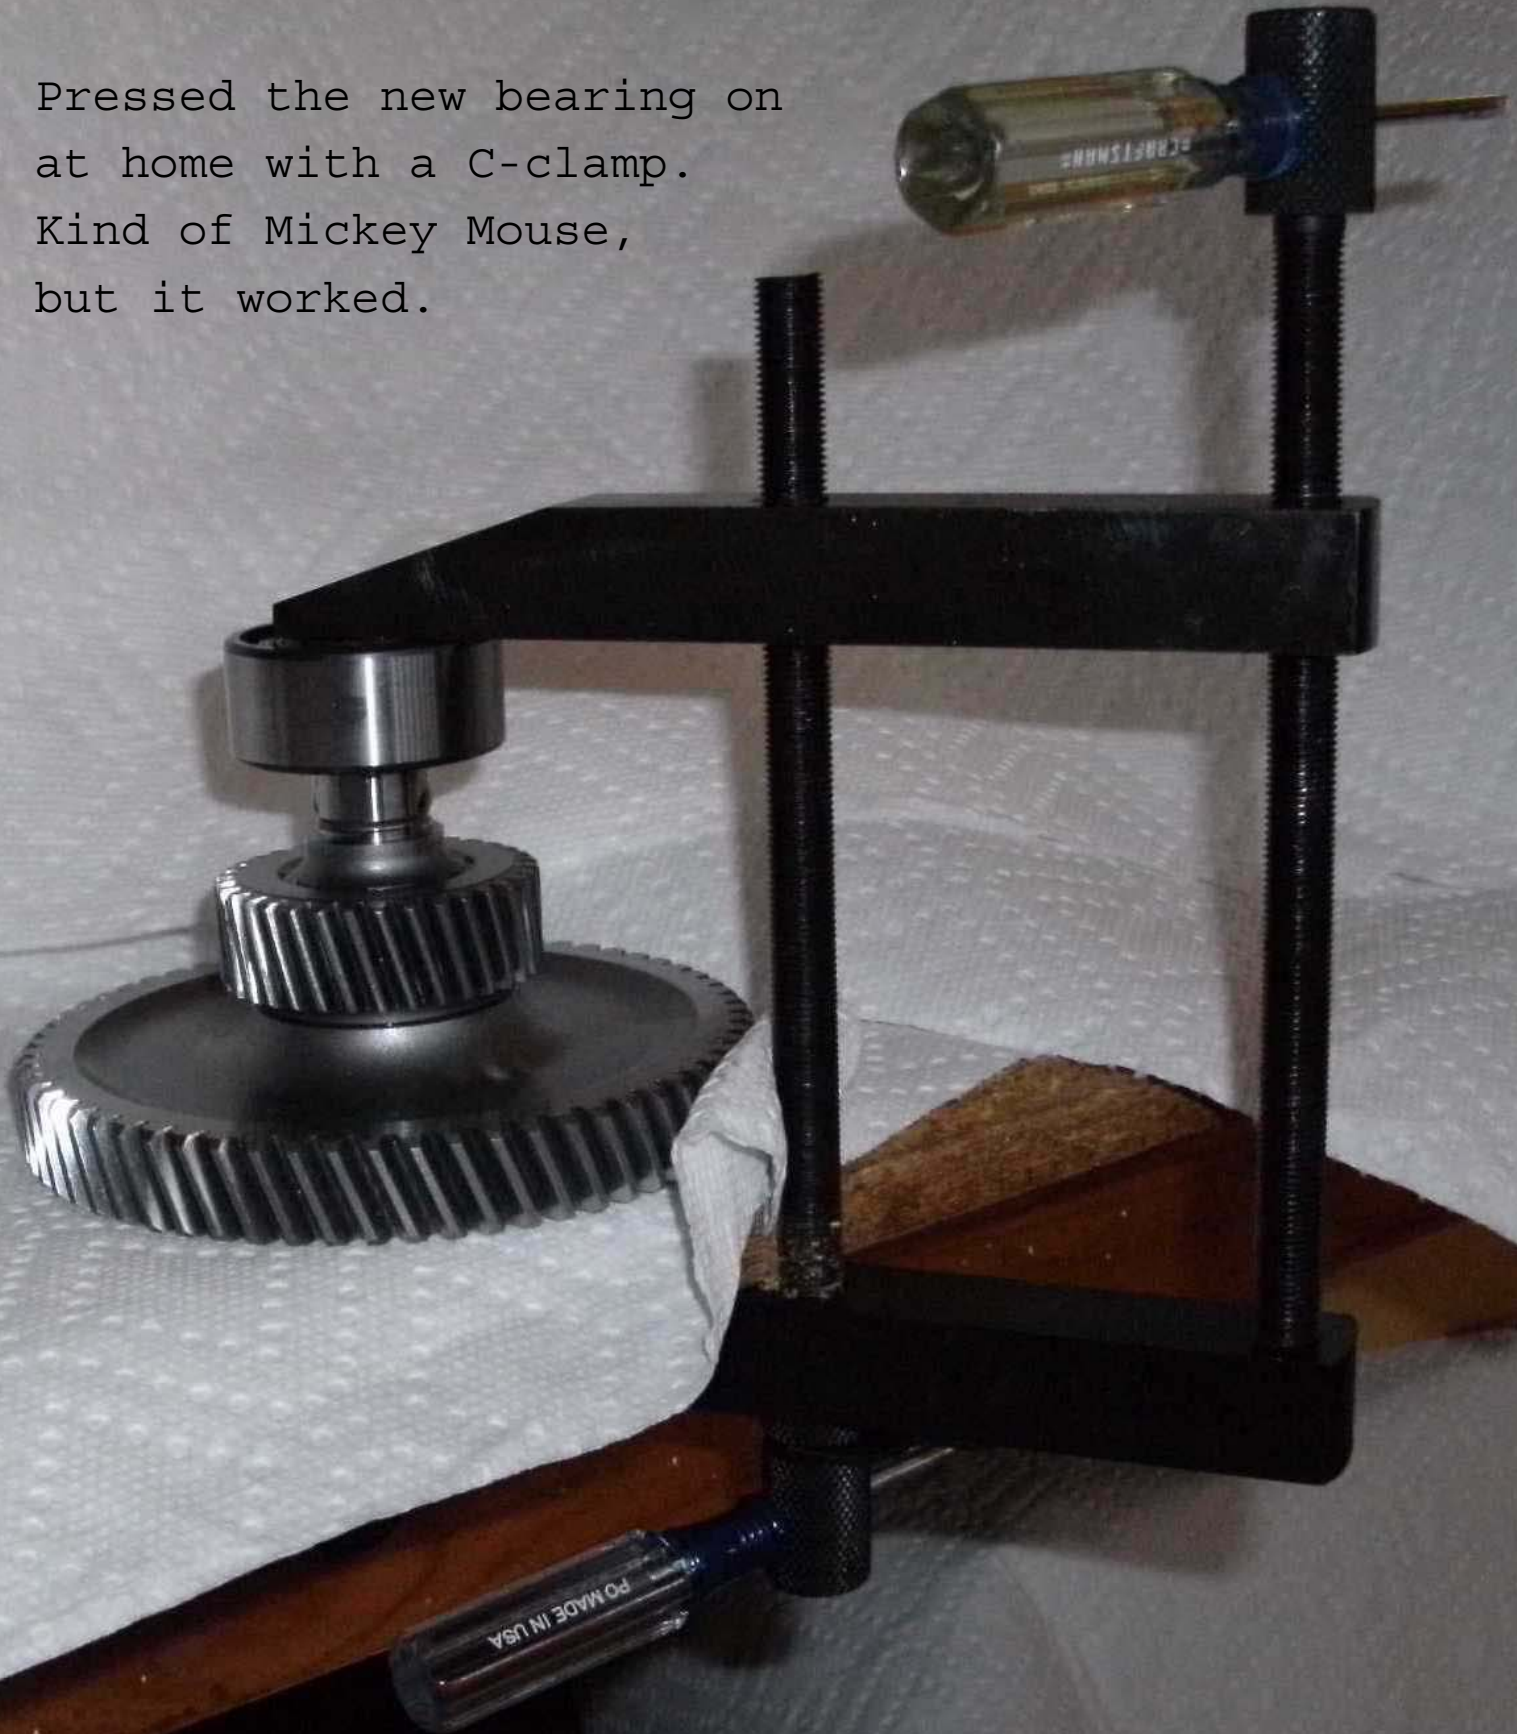
Pressed the new bearing on  
at home with a C-clamp.  
Kind of Mickey Mouse,  
but it worked.

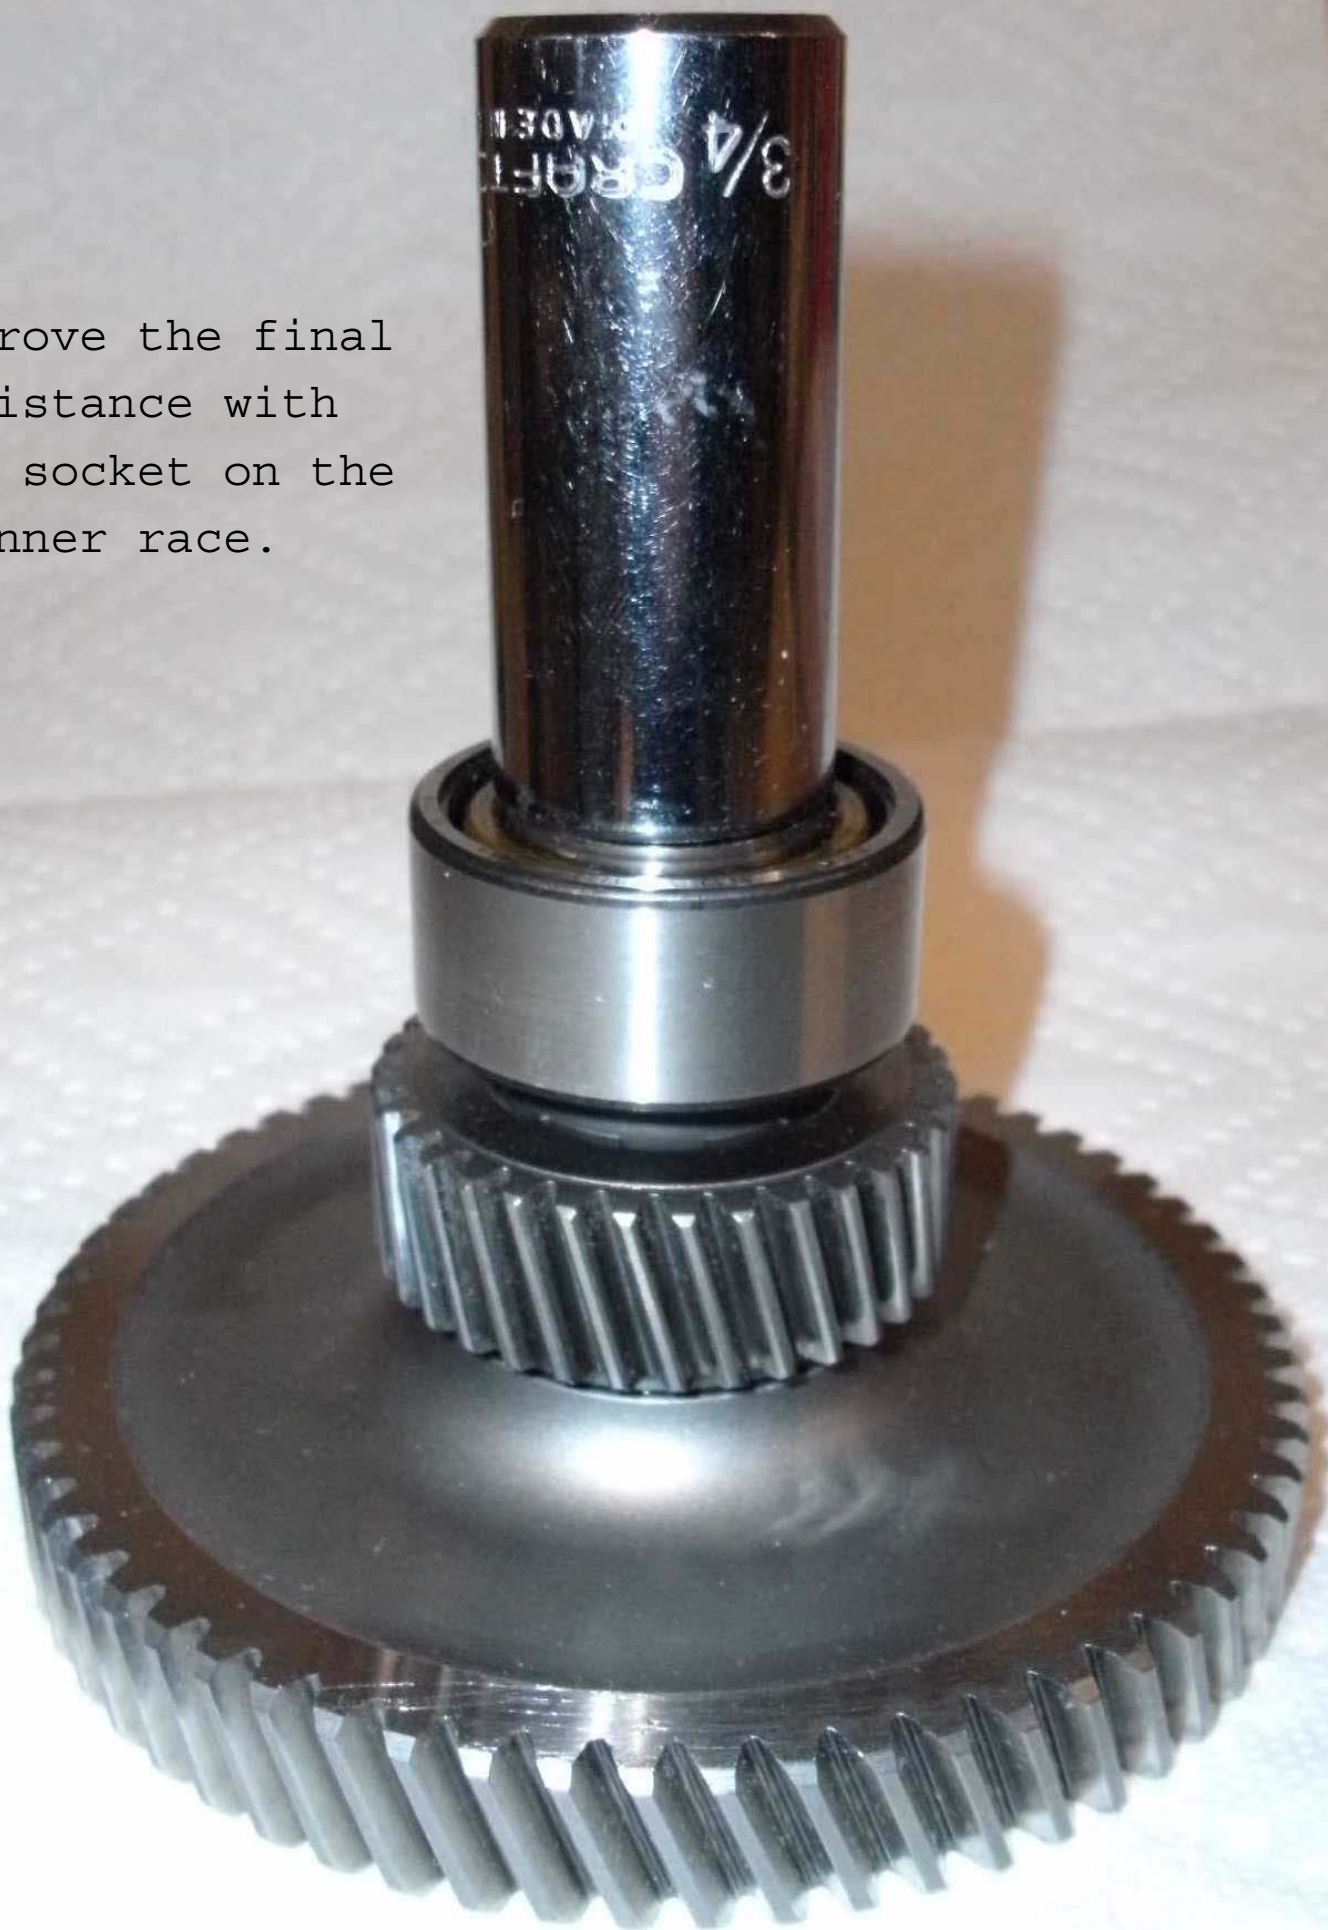
Drove the final  
distance with  
a socket on the  
inner race.
