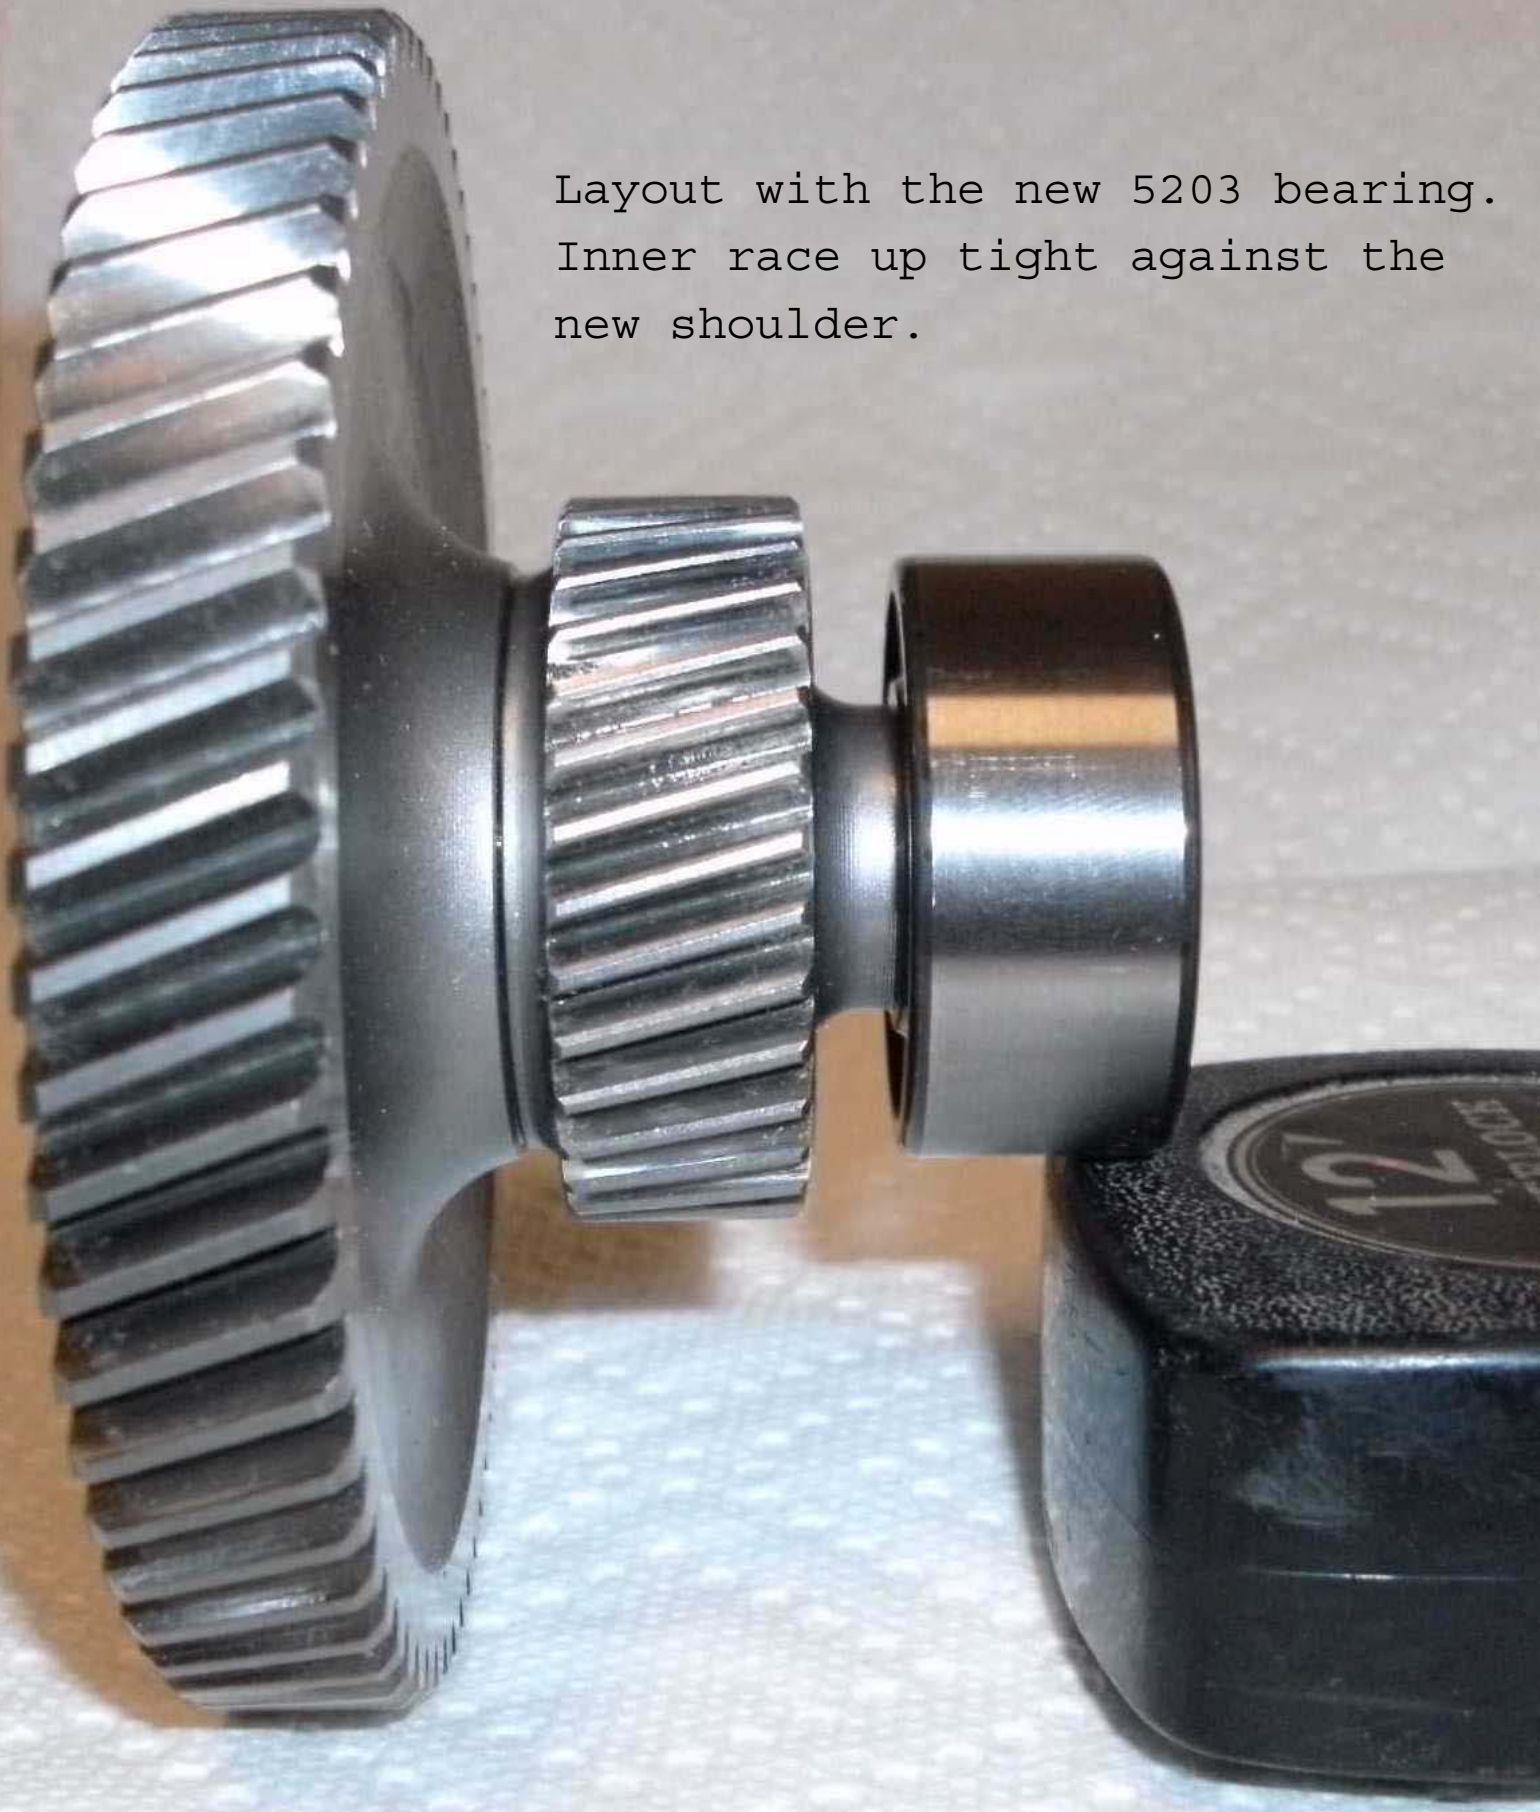
Layout with the new 5203 bearing.  
Inner race up tight against the  
new shoulder.

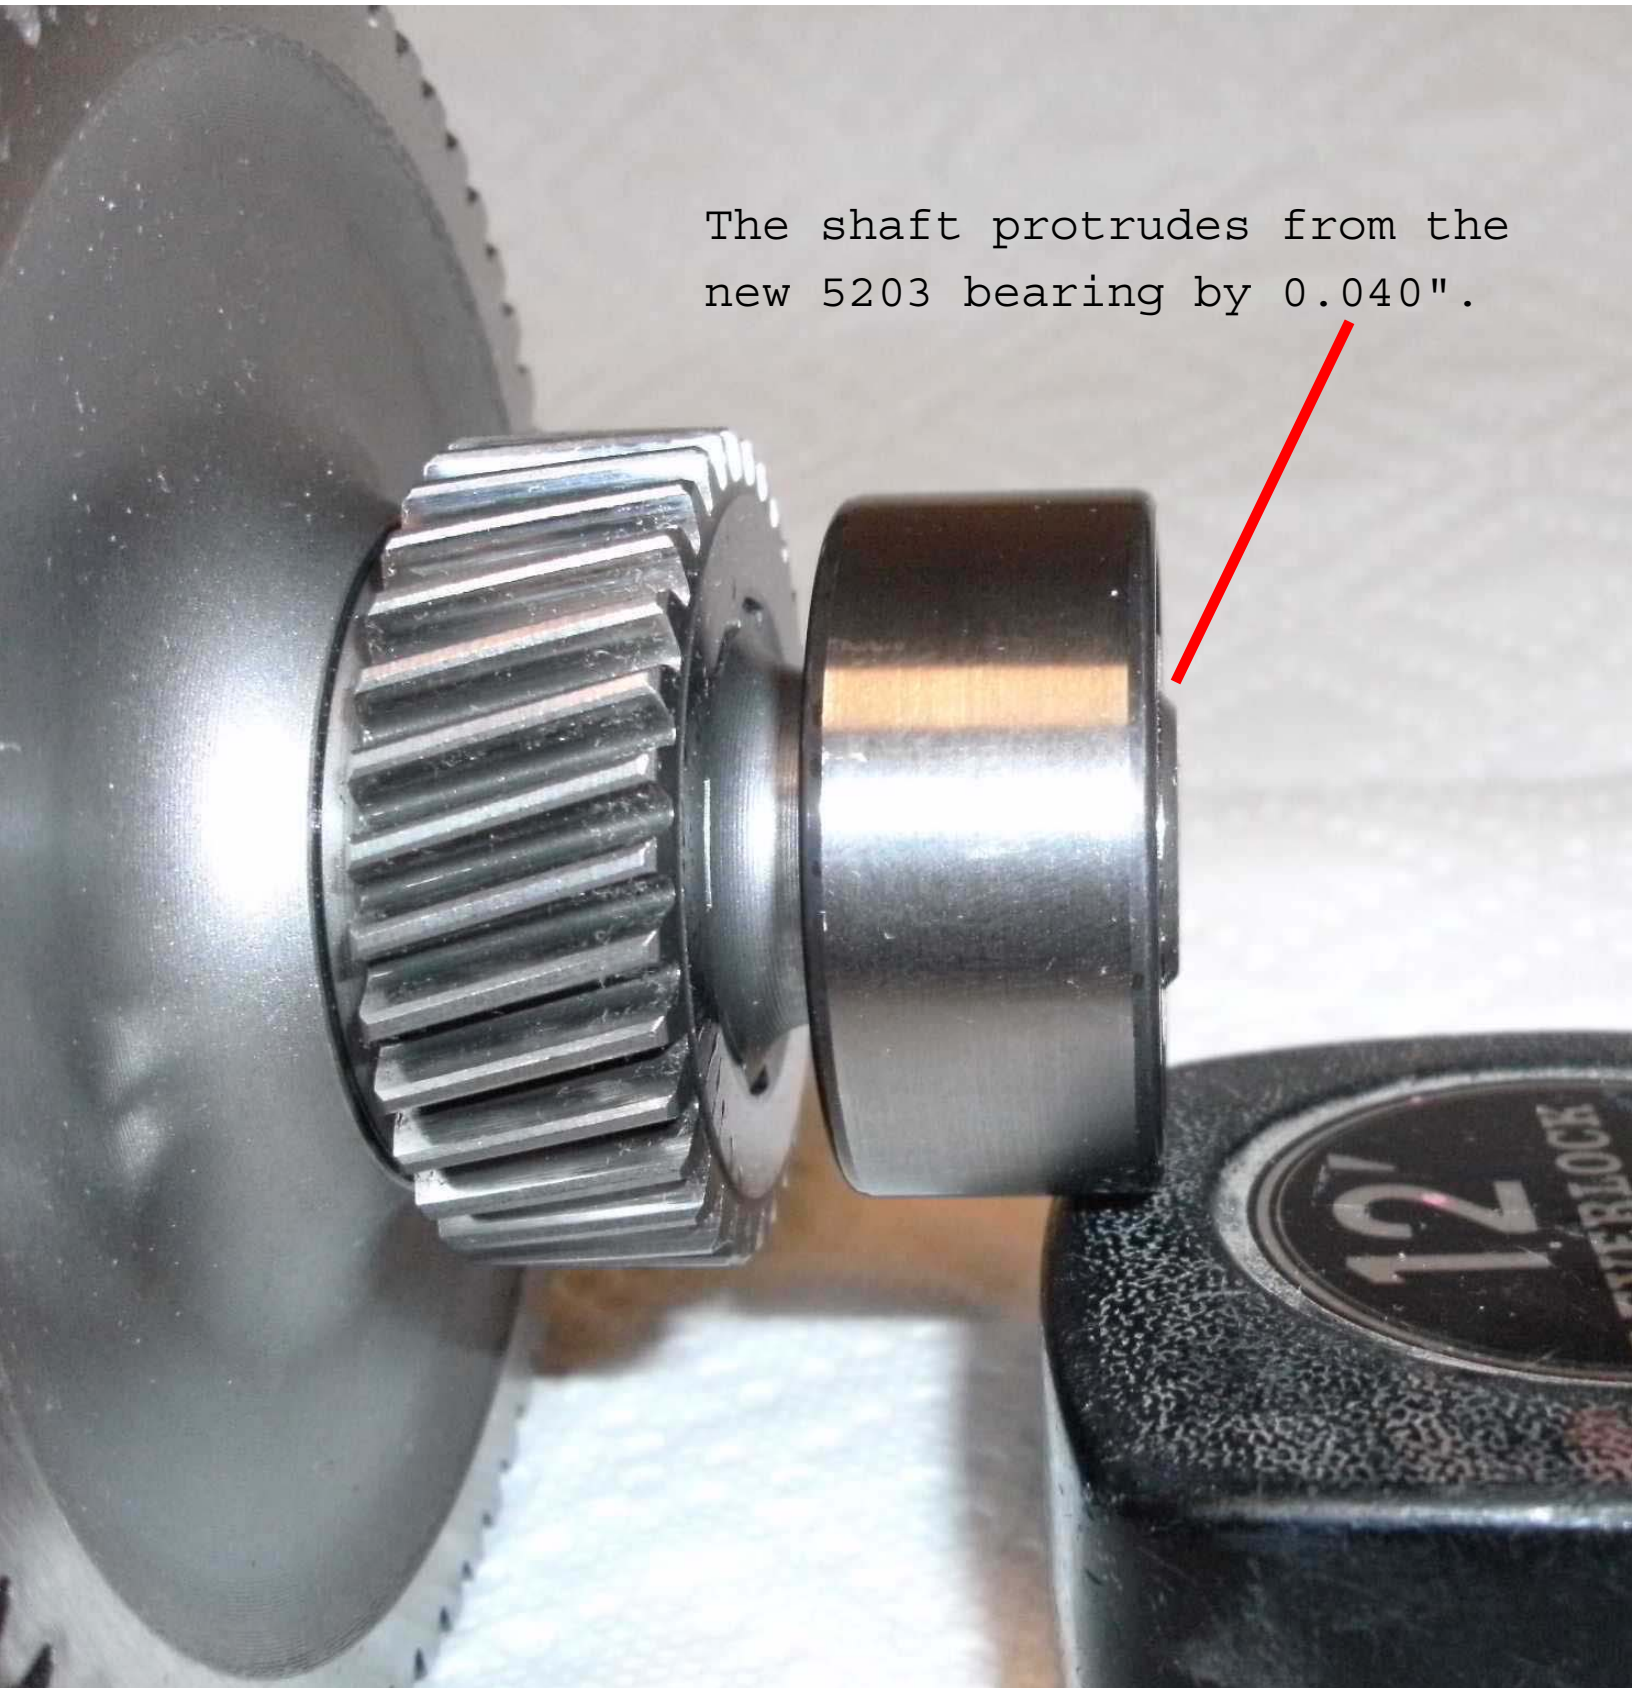
The shaft protrudes from the  
new 5203 bearing by 0.040".
